Preliminary evaluation of the seismic vulnerability of the Inca's Coricancha temple complex in Cusco

C. Cuadra¹, Y. Sato¹, J. Tokeshi, H. Kanno, J. Ogawa¹,
M. B. Karkee¹ & J. Rojas¹

¹ *Graduate School of System Science & Technology, Akita Prefectural University, Tsuchiya, Honjo, Akita, Japan*

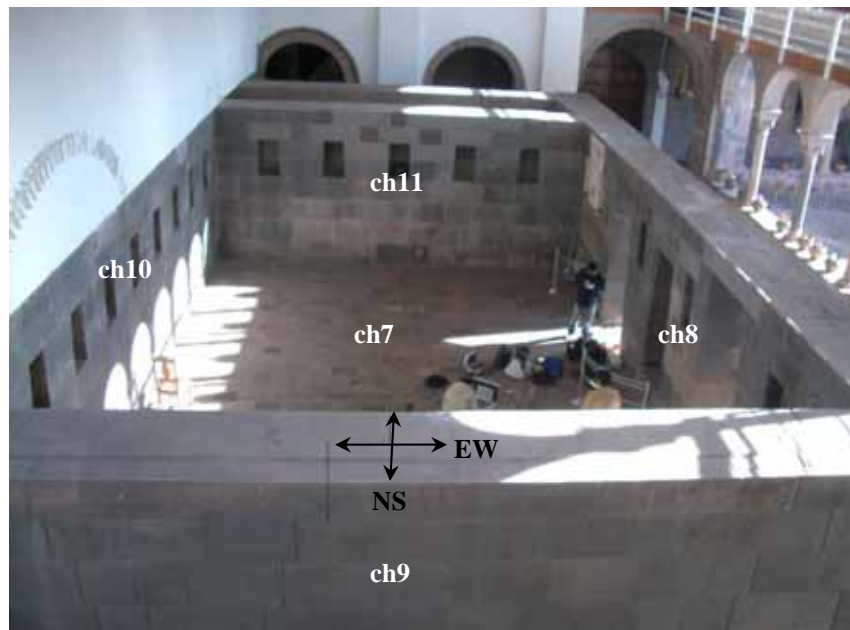
Figure 3: Point of microtremor measurements at temple of stars

Star Temple (Chasca): Structure Vibration. Measurements of horizontal vibrations in the two principal directions of the building were performed. The sensors were located on the floor level and at walls on all four sides. The sensors at the wall were located on the sill of rectangular offset on the inner wall face closest to center of the wall. The directions were designated NS and EW respectively. However, the actual directions are Northeast-Southwest (regarded as NS) and Northwest-Southeast (regarded as EW). The channels for measurement were denominated ch7, ch8, ch9, ch10 and ch11 as is shown in Figure 3.

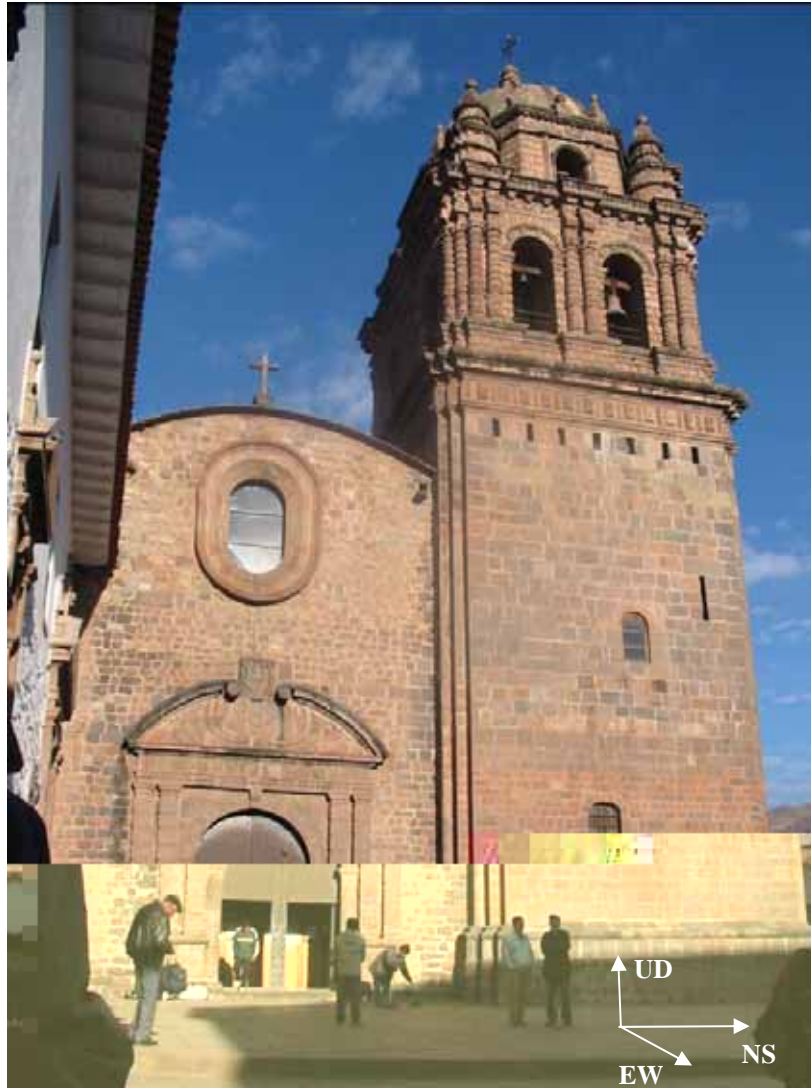
Figure 4: Tower of the Santo Domingo Church

Tower of Santo Domingo Church (Figure 4): Structure Vibration. Three

component of vibration were measured at the top and bottom of the tower. The directions for measurements are indicated in Figure 4.

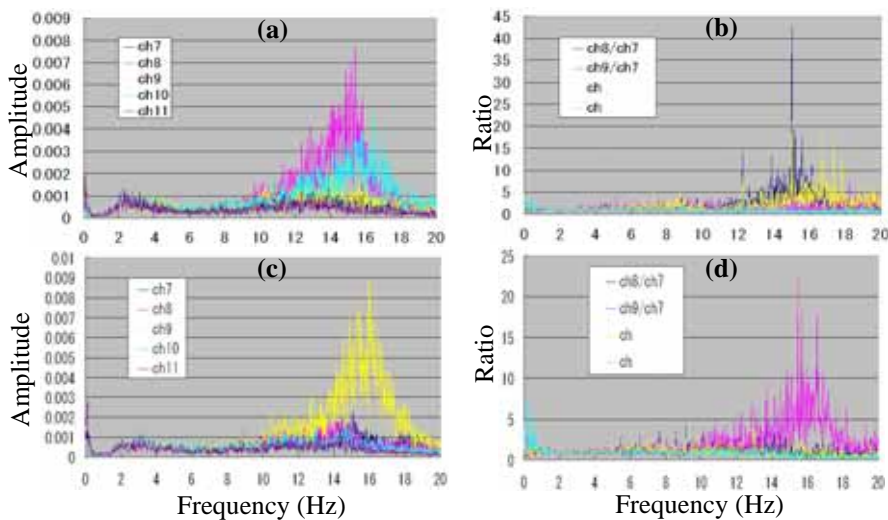
Figure 5: Fourier analysis results for the temple of stars

The location of the sensors on the temple of Stars is indicated in Figure 3. Channels 7 to 11 were measured simultaneously during 500 seconds. Then, stable portions of the records were selected to perform the Fourier analysis that permits to estimate the natural period of vibration of the structure. The results of the Fourier analysis are shown in Figure 5. Figures 5(a) and 5(c) show the Fourier spectrum for the EW and NS directions, respectively. The Fourier amplitude spectrum at each measured point of the structure was divided by the one at the ground level, to obtain only the vibration characteristics of the structure. It can be observed from Figure 5(a) and 5(b) that the value of the predominant frequency in the EW direction ranges from 14 to 17 Hz. In case of the NS direction, these values range from 12 to 16 Hz as is shown in Figure 5(c) and 5(d). These differences are due to the presence of a colonial wall on the east wall of the star temple. On the other hand, the length of the wall differs for the EW direction and NS direction, and therefore, each wall vibrates with different frequency. Therefore, the vibration of the structure is intricate and further measurement and analysis is required to establish its seismic behavior. In any case, the predominant frequency is relatively high.

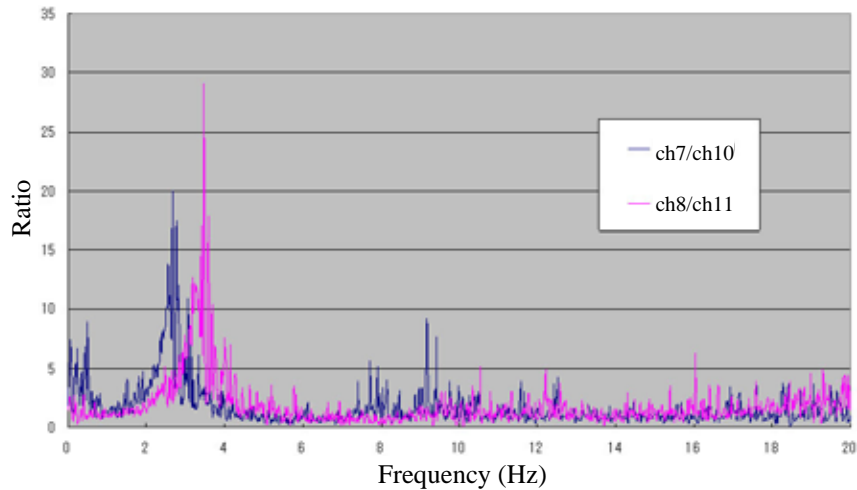
Figure 6: Fourier analysis results for the tower of Santo Domingo Church

Figure 6 presents the results of the Fourier analysis for the horizontal vibration of the Colonial tower. These directions NS and EW are indicated in Figure 4. The Fourier amplitude spectrum obtained at the top of the tower was divided by the one obtained at the ground level, to obtain only the vibration characteristics of the structure. It can be observed that the value of the predominant frequency in the EW direction is 2.7 Hz, and in the NS direction is 3.3 Hz.

It was found that the predominant period of vibration of the church tower is comparable to the predominant period of the ground, and therefore the tower appears to be more vulnerable in case of earthquake occurrence because of the possible resonance phenomenon to be expected.

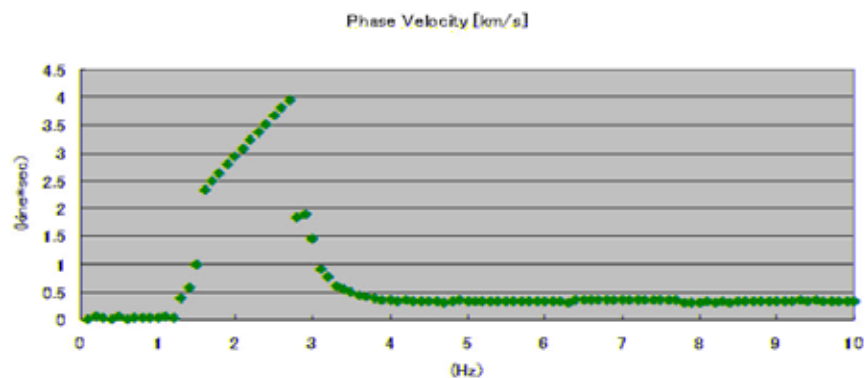
Figure 7: FK analysis result for Coricancha ground site

Figure 7 presents the dispersion curve obtained from the FK analysis. This result permits to estimate the predominant frequency of the ground as 2.7 Hz. Then, if the result is compared with that obtained for the tower of the Colonial Church, it can be observed that the frequency of the structure and soil are similar, and therefore, the resonance phenomenon is expected to occur. This coincidence of the predominant frequencies could be the explanation of the repeatedly failure of the tower during past earthquakes.
