### 1.7. Building No 2 of the Group of the Mortars: Gable wall and structure vibration

### 1.8. Terraces at low part of Group 13: Ground vibration (horizontal sensors)

## 2. Measurements at Coricancha Complex

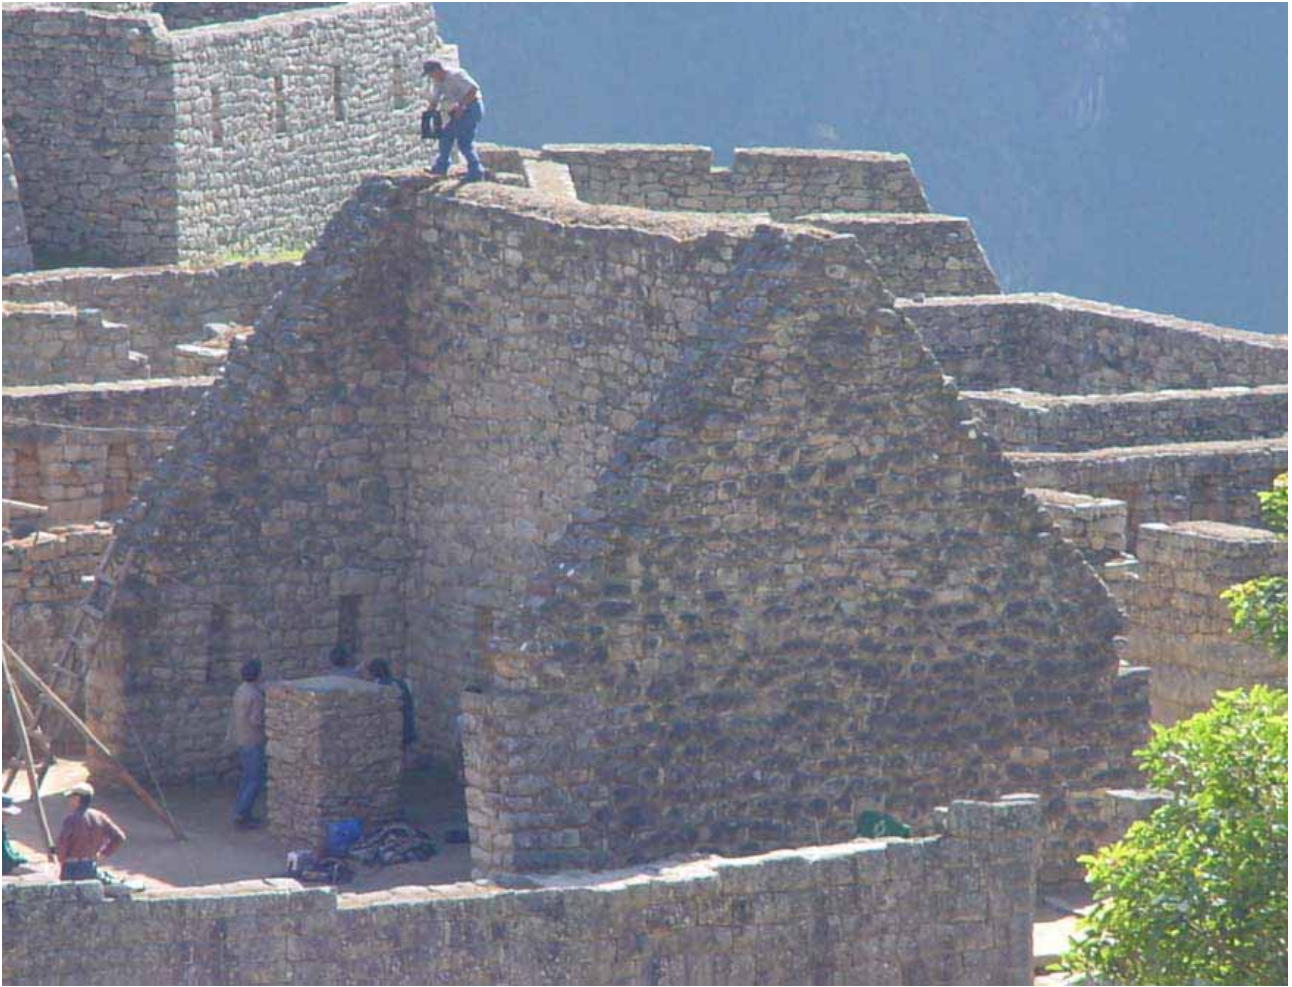
Horizontal vibrations of the structure and ground were measured in this site. The points of measurement were the top of the central wall, the bottom part of the gable wall, the central window of the central wall and the ground. Measurements were carried out for NS direction and EW direction separately. The measurement at this structure is of special interest since its mode of vibration can be compared with the mode of vibration of the previous structures to analyze the restraining effect of the central wall on the behavior of the gable wall. Time domain plots are shown below.

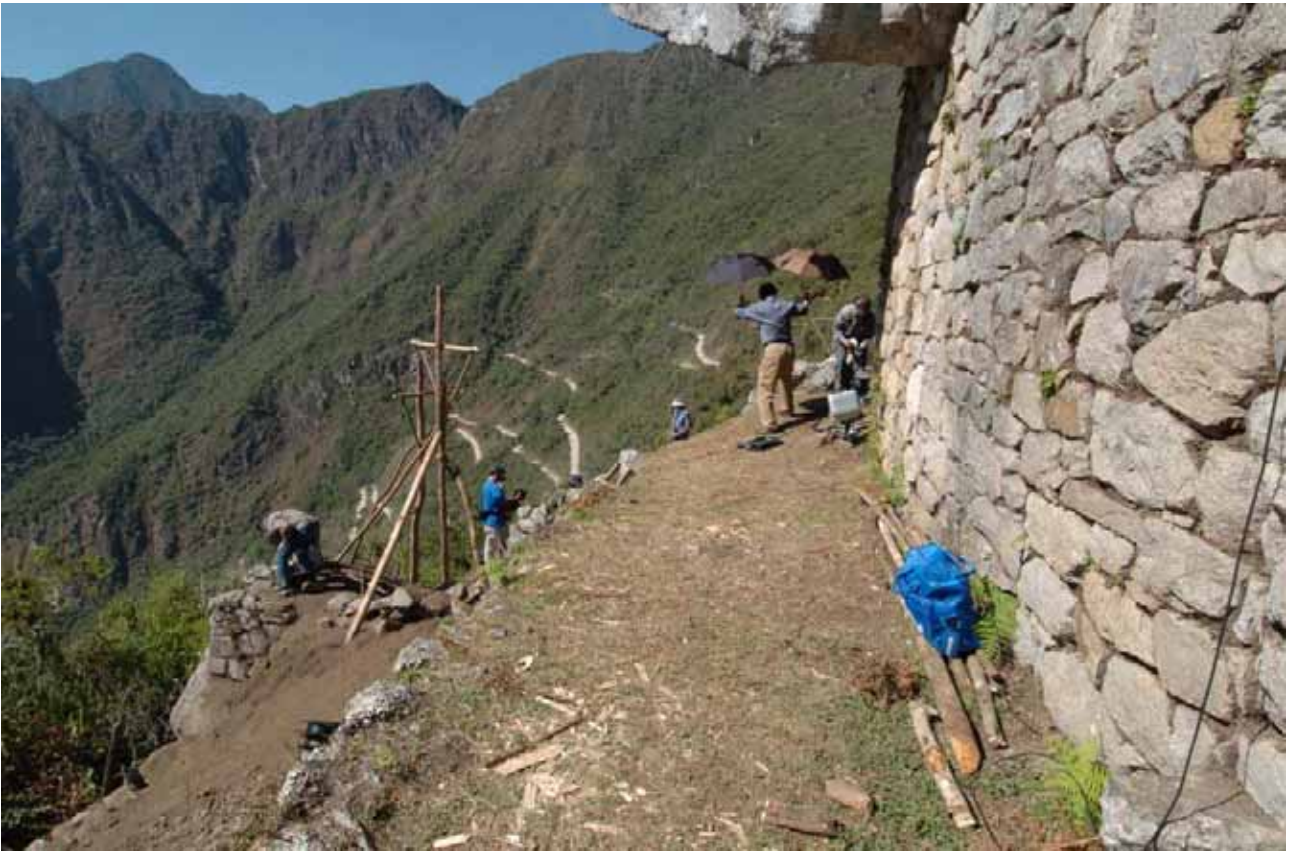
Here the horizontal vibration of the terraces was measured. The direction of measurements was transversal to the valley (right to left in the photograph). Measurements were performed here to analyze the behavior of the terraces since they are affected by landslides that may also be triggered by earthquakes. The measurement was performed simultaneously in four consecutive platforms. The time domain plots of the measurements are shown below.

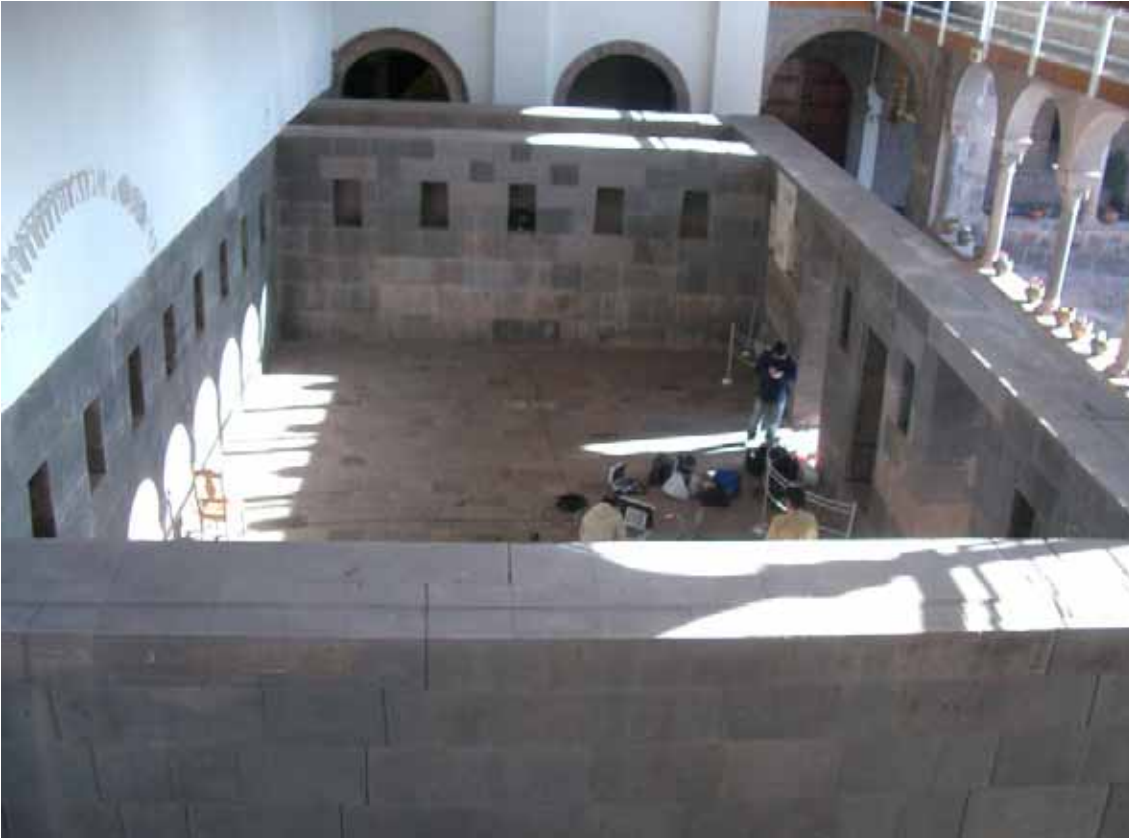
### 2.1. Star Temple (Chasca): Structure Vibration

Measurements of horizontal vibrations in the two principal directions of the building were performed. The sensors were located on the floor level and at walls on all four sides. The sensors at the wall were located on the sill of rectangular offset on the inner wall face closest to center of the wall. The directions were designated NS and EW respectively, but the actual directions are Northeast-Southwest (regarded as NS) and Northwest-Southeast (regarded as EW). Time domain plots of the results of measurements are shown in the following figures:
