## 5. Pisac

## **5.1 Typical construction: Structure vibration**

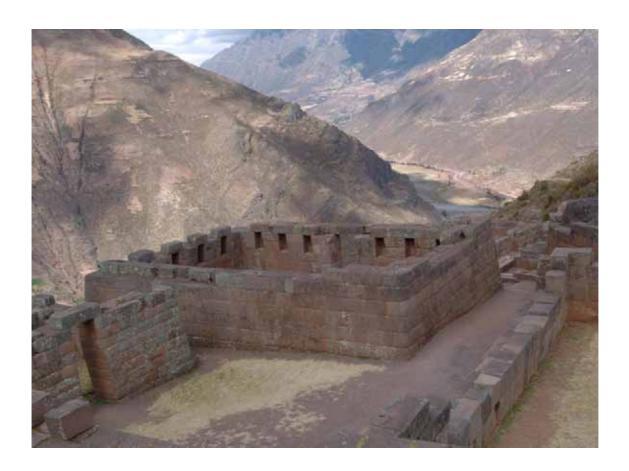
One of the typical constructions in the zone of the Intihuatana in the ruins of Pisac, was selected for microtremor measurements. Horizontal vibrations in the two principal directions of the building were performed. The sensors were located on the floor level and on walls on all four sides. The sensors at the wall were located at the top central part of each wall. The directions were designated as NS and EW, which correspond approximately to the actual orientation of the walls. In the photograph the wall face corresponds approximately to the east-west direction. The time domain plots from the results of the measurements are shown in the following figures.
