SEISMIC DAMAGE TO STONE STRUCTURES IN MACHU PICCHU

C. H. Cuadra¹, K. Tokeshi² and J. G. Rojas³

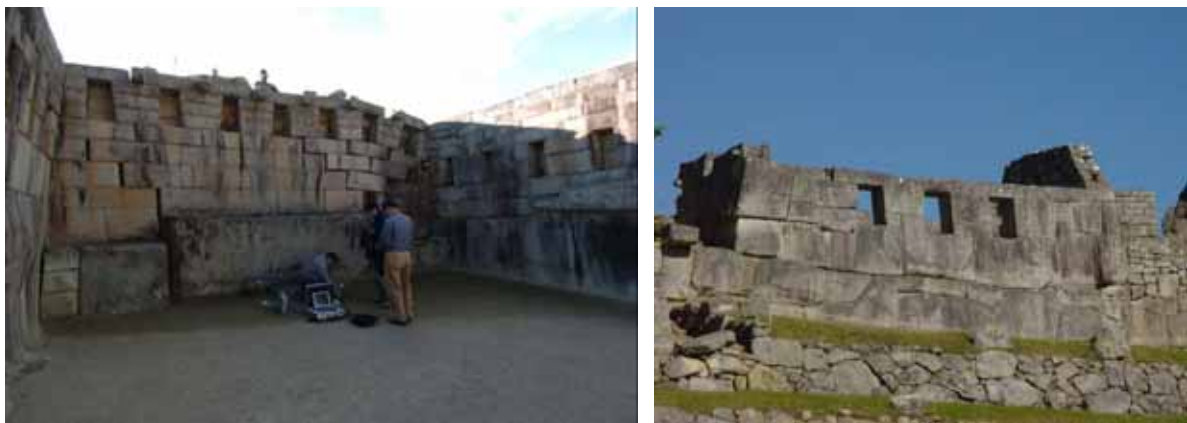
Figure 3. Details of the Main Temple and Temple of the Three Windows

In previous research (Cuadra *et al.*, 2008), the equivalent Young elastic modulus for the first and the third style was studied. In this research, the second style was chosen to complete the study on the equivalent Young modulus of elasticity, and also to study the failure of this type of constructions in Machu Picchu. The targeted buildings and its overall location in Machu Picchu are shown in Figure 2. The Main Temple and the Temple of the Three Windows are located in the Sacred Plaza sector. Details of the Main Temple and the Temple of the Three Windows can be observed in Figure 3. The Main Temple shows damages of displacements between stone blocks of the north wall due to the settlement of the east wall (Figure 3 (a)). In the case of the Temple of the Three Windows, relative horizontal displacements of stone blocks can be observed (stone blocks on the left of Figure 3 (b)).

Figure 4 shows the H/V spectral ratio obtained from microtremor measurements at the ground of Sacred Plaza. A predominant frequency of 23.7 Hz was estimated, which would mean that depth of the bedrock is shallow. Usually, the natural frequency of the ground ranges between 1 Hz for soft soil deposits and 10 Hz for hard soil deposits. Therefore, the estimated predominant frequency of 23.7 Hz indicates that the thickness for soft soil layer would be very thin (around 1 m) and that the bedrock would be close to the ground surface. In consequence, these buildings would be founded directly on the bedrock. The soil settlement failure observed apparently in Figure 3(a) would correspond to a failure in the bedrock. In that case, it is probable that some mechanical action on bedrock has produced the cracking of the rock, and as consequence, it has been the cause of settlement in the east wall of the Main Temple.

Finally, the horizontal sliding between stone blocks in the Temple of the Three Windows could be consequence of strong seismic forces of past earthquakes.

The settlement observed in the Main Temple is probably due to the fracture of the subjacent bedrock in which the building is founded.

The particular horizontal sliding between stone blocks at one wall corner of the Temple of the Three Windows could be consequence of strong seismic forces of past earthquakes.

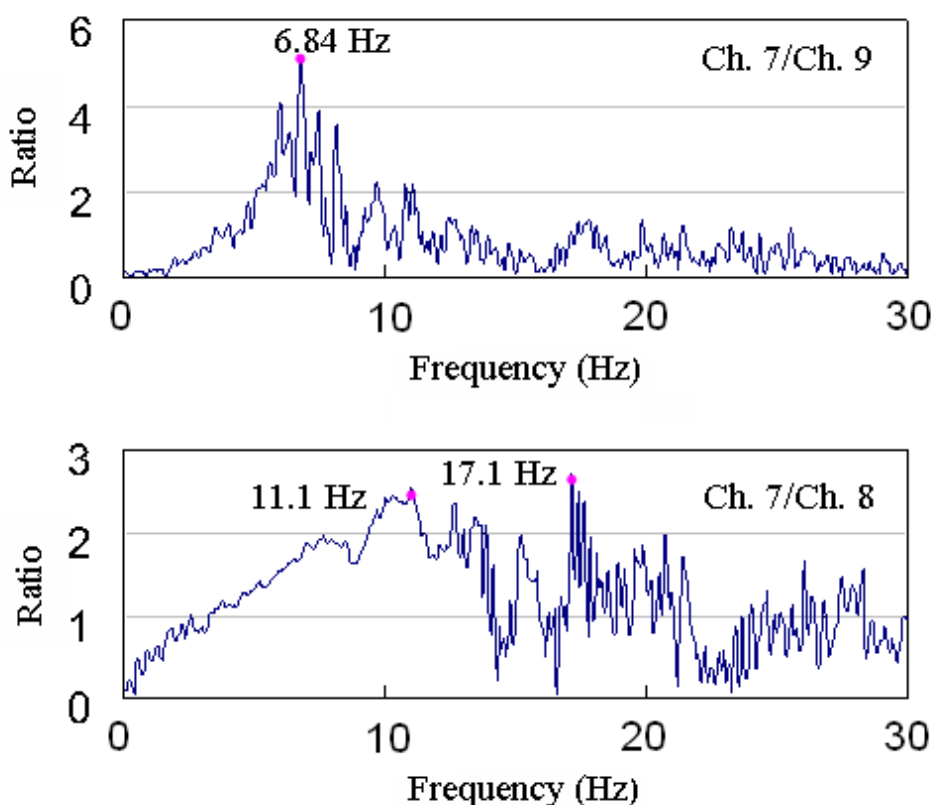
Figure 6. H/V spectral ratio along the EW direction in the Temple of the Three Windows

To estimate the dynamic characteristics of the Temple of the Three Windows, the transfer functions between Ch. 9 and Ch. 7 and between Ch. 8 and Ch. 7 were computed, which results along the EW direction are shown in Figure 6. According to these results, the predominant frequencies of the west wall is 6.84 Hz when considering the transfer function from the external ground surface to the top of the wall (Ch. 7/Ch. 9). When the transfer function from the inner ground surface to the top of the wall is considered, the predominant frequency is 17.1 Hz (Ch. 7/Ch. 8).
