PRELIMINARY OBSERVATIONS ON DAMAGE TO BUILDINGS IN GUJARAT (WESTERN INDIA) EARTHQUAKE OF JANUARY 26, 2001

Madan B. KARKEE

Naoyuki ITAGAKI

ABSTRACT: About three weeks after the Gujarat earthquake, the authors were deployed by the Department of Architecture and Environment, Akita Prefectural University, to undertake a preliminary assessment of the nature of damage to buildings in some of the affected areas of Gujarat. The trip was organized over a very short period and without any detailed planning and without benefit of adequate prior information about field conditions in the earthquake aftermath. Actually, primary objective was to gather the basic necessary factual information about the actual situation in the affected region, based on which other institutions in Japan may be able to organize teams of engineers for more detailed investigation. Further, considering the relief work that was expected to be in full force, the field observations were kept as unintrusive as possible. This report attempts to summarize some preliminary observations based on the field trip by the authors, and mostly consists of photographs of damaged buildings.

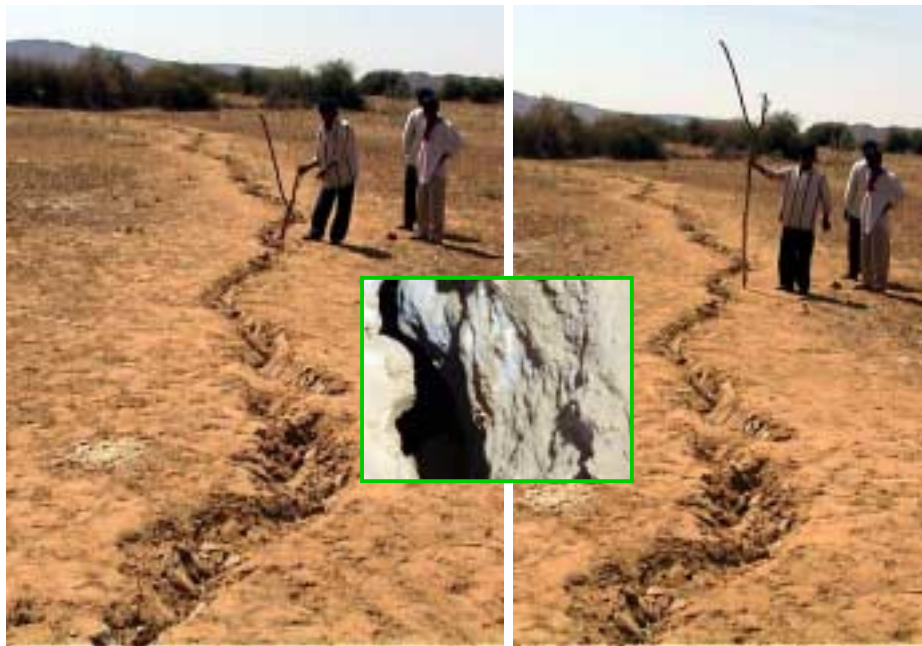
Figure 6. Extensional deformation over alluvial deposit observed near Lodhai. The inset shows the close-up view from within the cracks, where the evidence of salt-water expulsion may be noted from the salt deposit after evaporation.

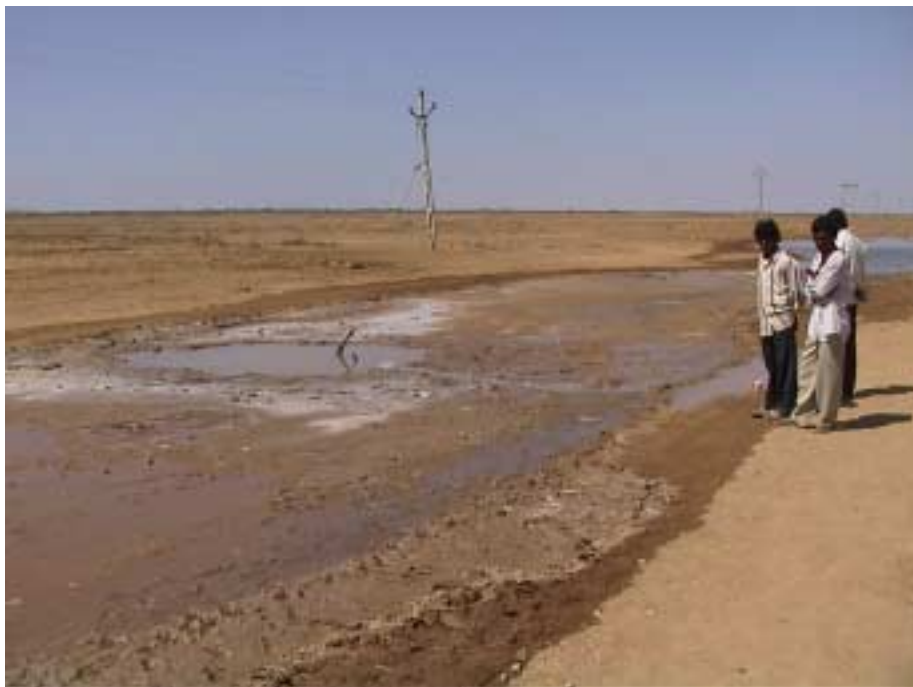
Figure 7. Sand boil and expulsion of salt water to the surface observed near Lodhai at a location to the east of that shown in Figure 6. Water was still oozing out when the authors visited the site on February 23, 2001.

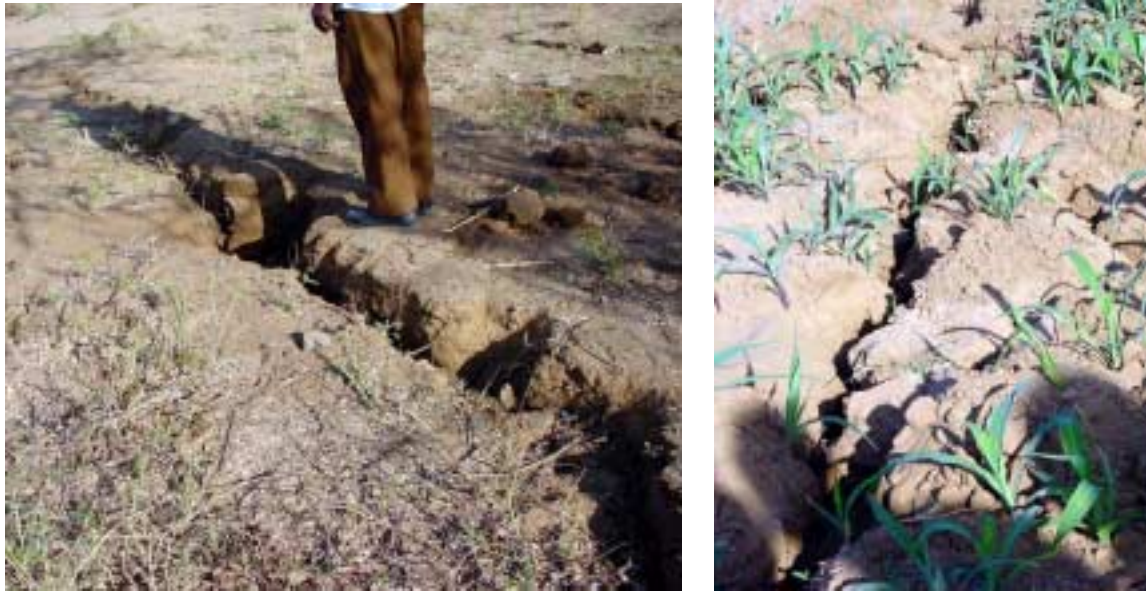
Figure 8. Extensional ground cracks observed near Chaubari stretching over barren land and corn fields

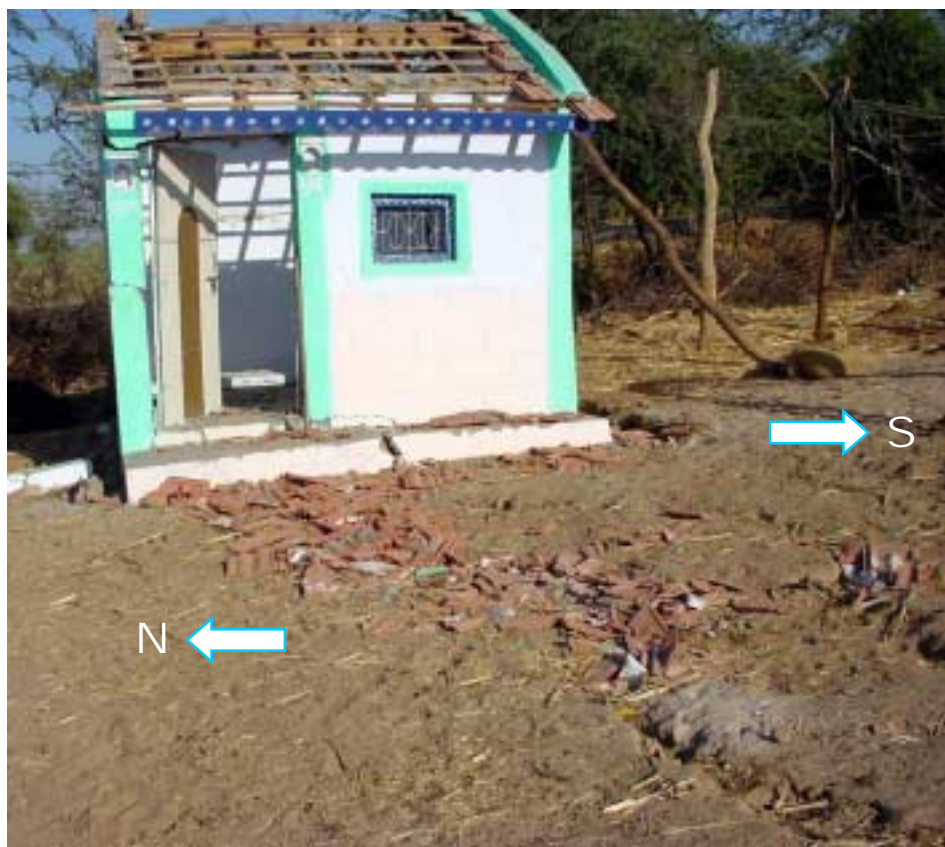
Figure 9. Extensional ground cracks crossing a small hut located in between the barren land and the corn field shown in Figure 8, with the corn field to the west.

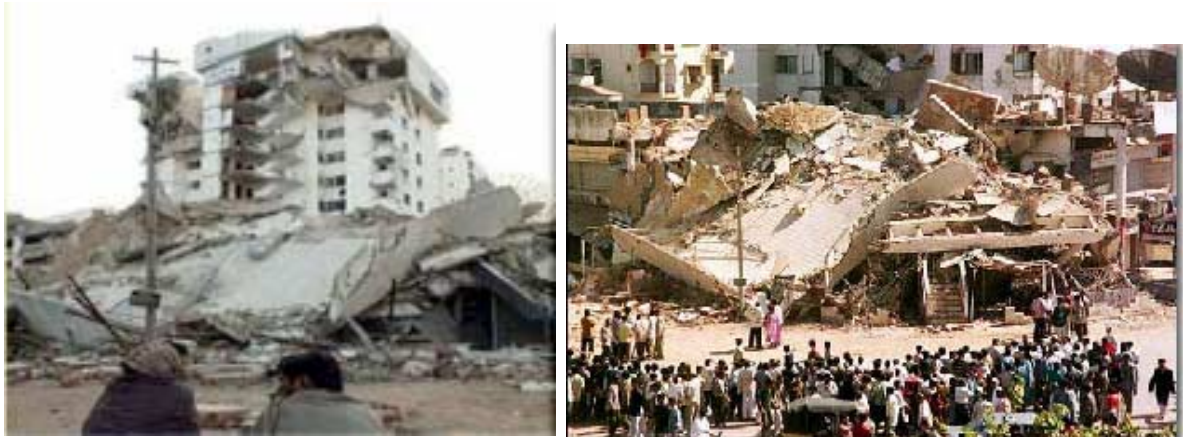
Figure 10. General and close-up view of the damaged multistory building (Manasi complex) in Ahmedabad soon after the earthquake. Photograph from the web page shown above.

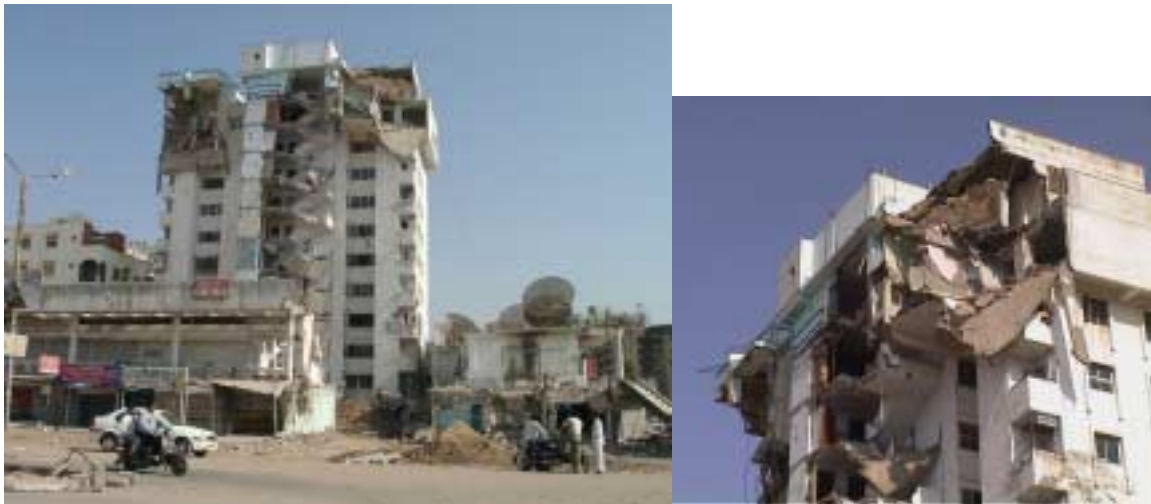
Figure 11. General and close-up view of Manasi complex when the authors visited on February 20, 2001.

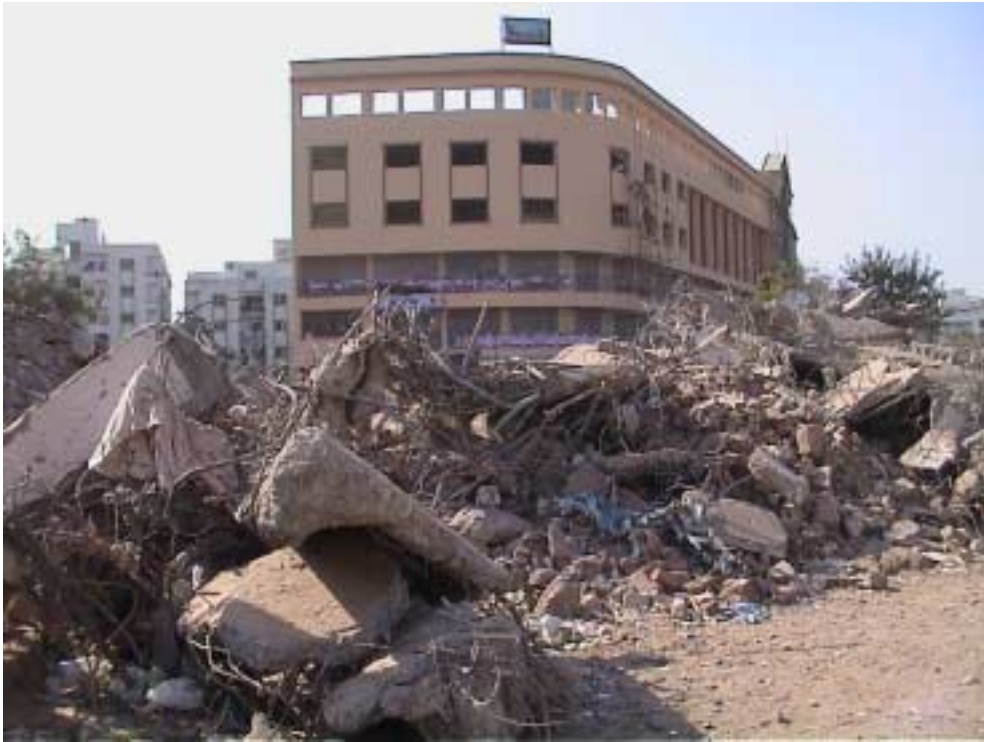
Figure 12. The rubble of concrete and reinforcement from the collapsed portion of the Manasi complex dumped across the street nearby. Most of the buildings seen in the background seem to have little if any structural damage.

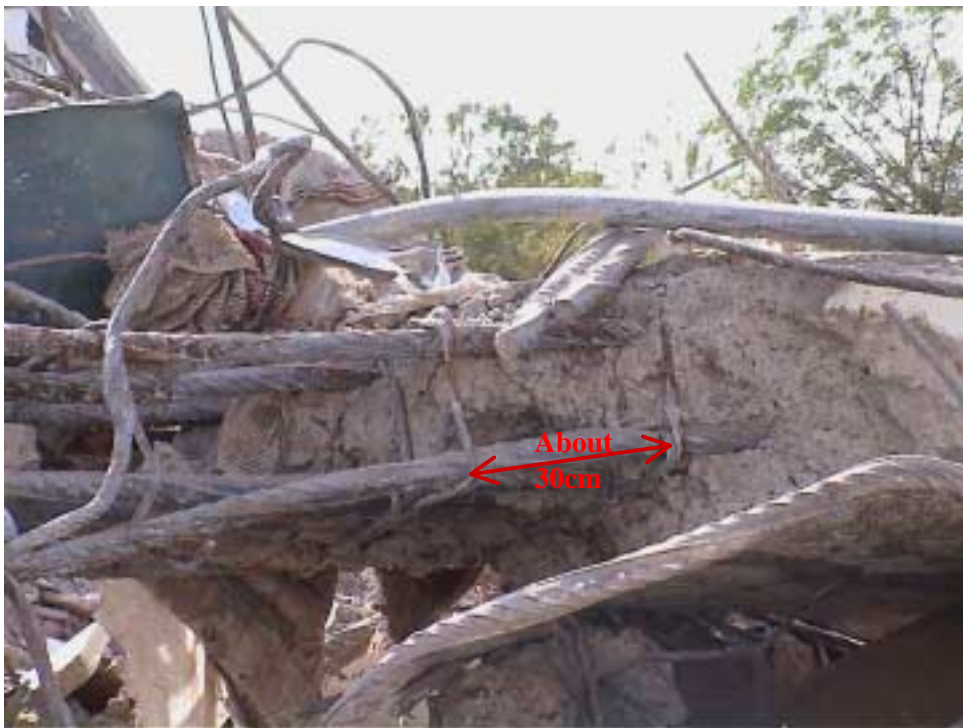
Figure 13. Close-up view of the rubble from Manasi complex, showing the nature of reinforcement placement and the quality of concrete utilized in columns in the collapsed portion.

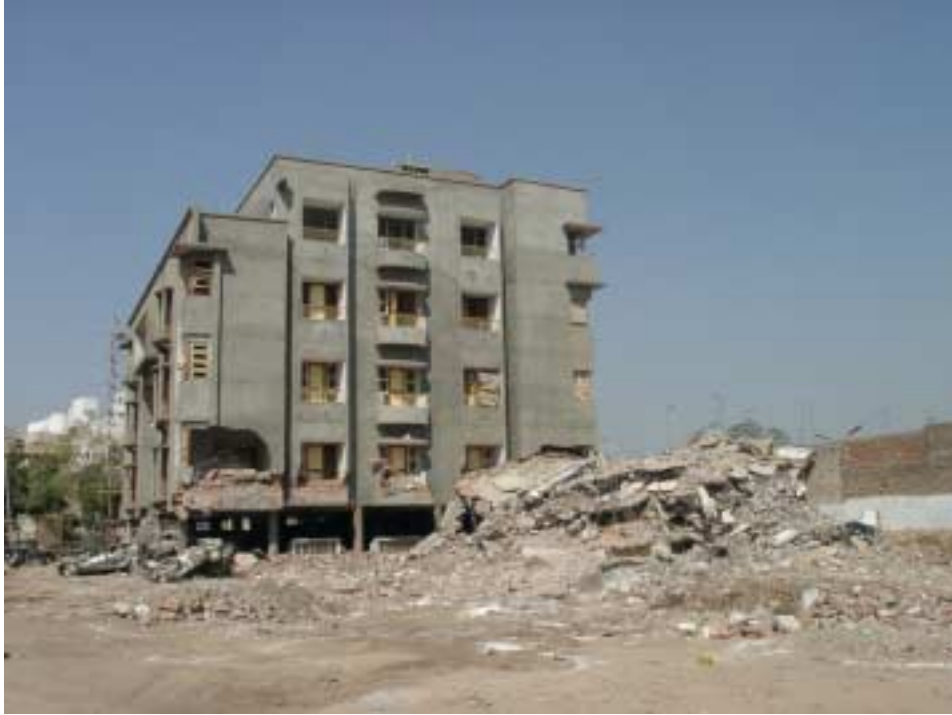
Figure 14. Wreckage of collapsed building and crushed vehicles parked in the open ground floor, near Maninagar station, south east of Ahmedabad. The adjacent building with open first floor parking space sustained some damage mostly due to the impact of collapsed building.

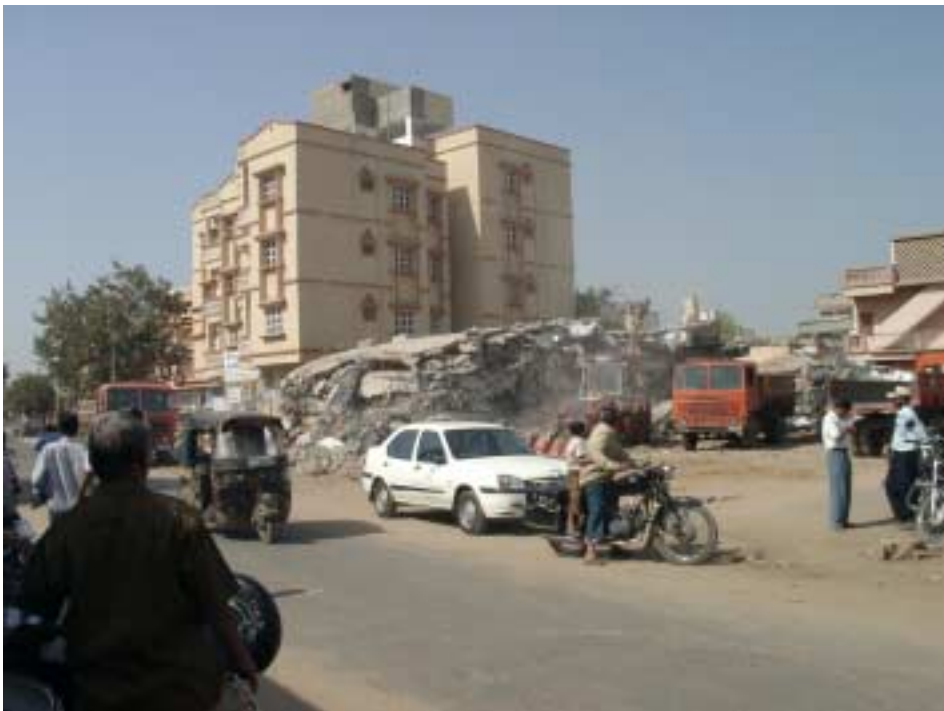
Figure 15. Wreckage of collapsed elementary school building in Khokhra, north of Maninagar, Ahmedabad. The adjacent 4 story Cadila health center building and other surrounding buildings appeared to suffer minimum if any damage.

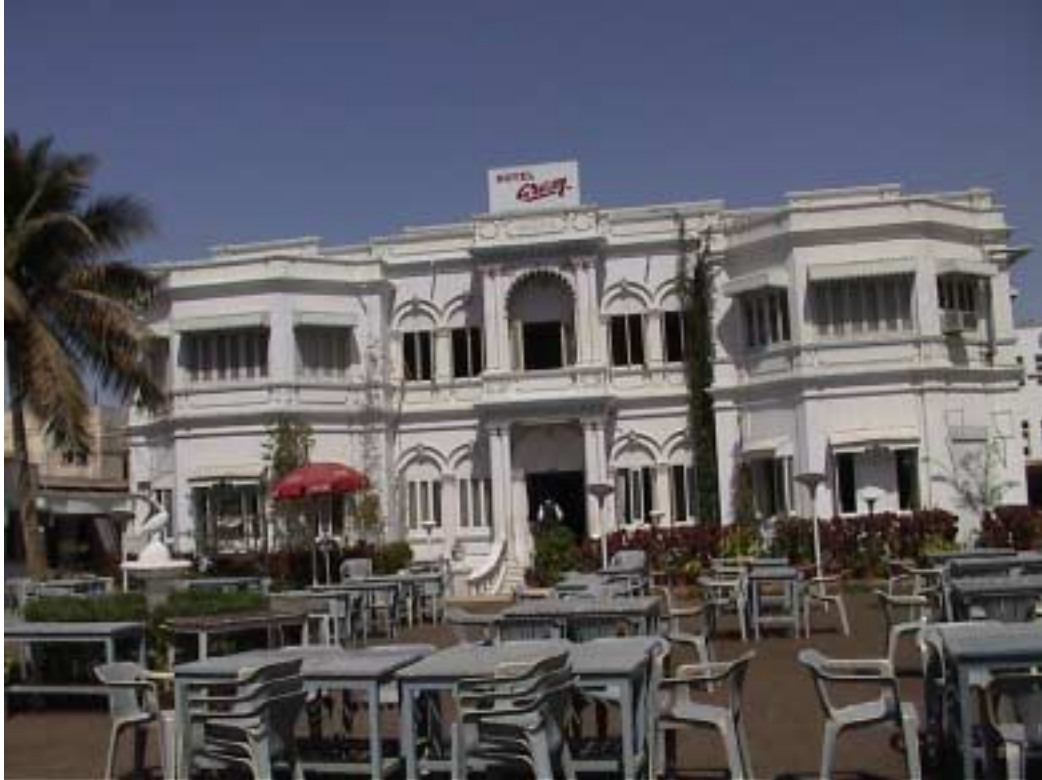
Figure 16. Hotel Aram in Jamnagar, consisting of a stucco building dating back to the times of British India. The building looked intact from distance and it was in business. However, looking closer it was found that the building had many cracks and owner some repair of the damage was undergoing as the hotel was running.

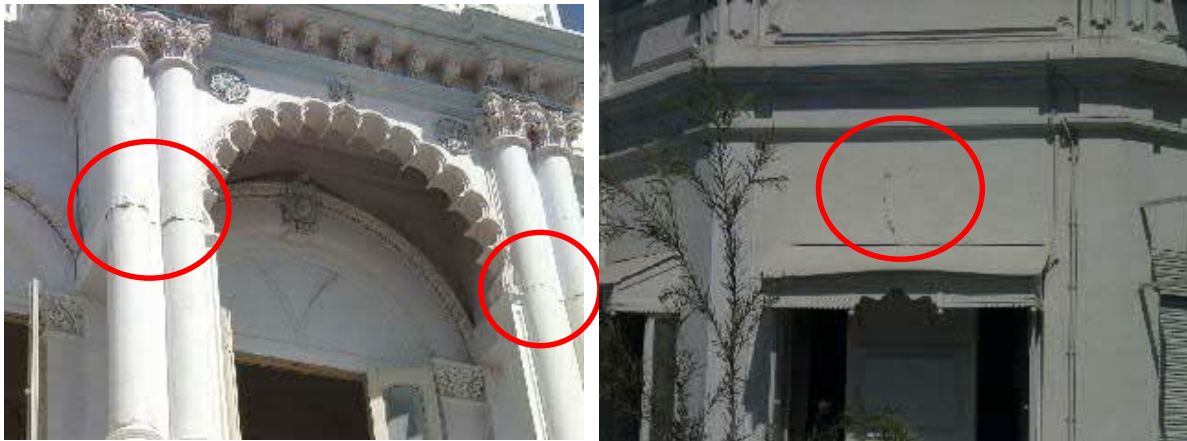
Figure 17. Closer look at the cracks on the exterior walls of Hotel Aram building. The cracks and damages on interior walls may have been more severe at sections the owner had already undertaken repairs and covered with cement mortar.

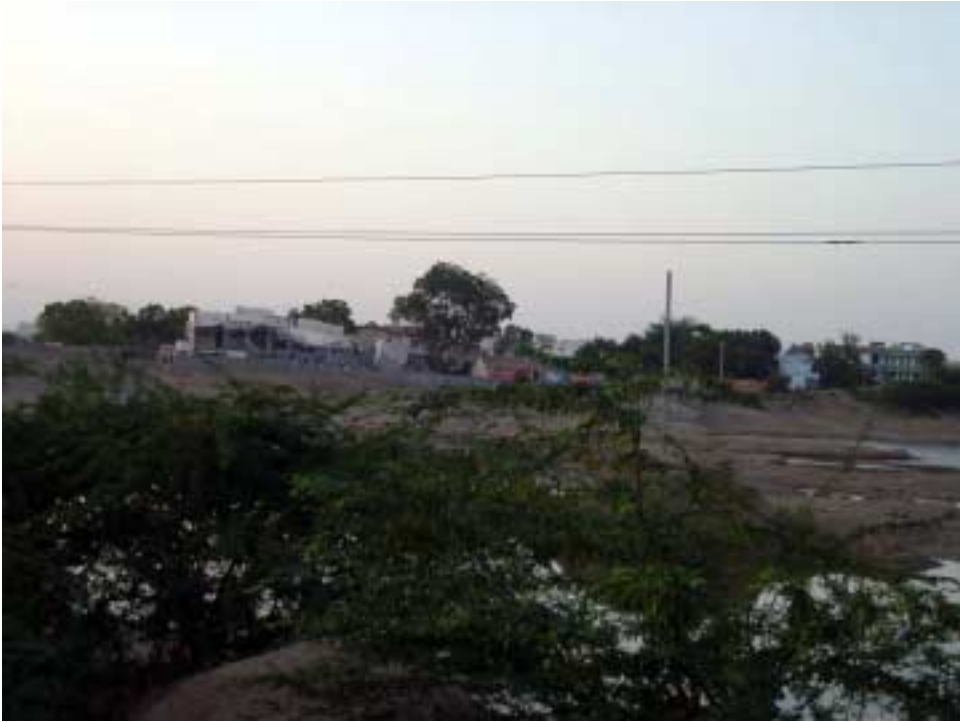
Figure 18. Damage seen from the road at Samakhial, on the way to Bhuj from Rajkot on Feb 22, 2001. The location is about 90km east of Bhuj and about 20km east of Bhachau.

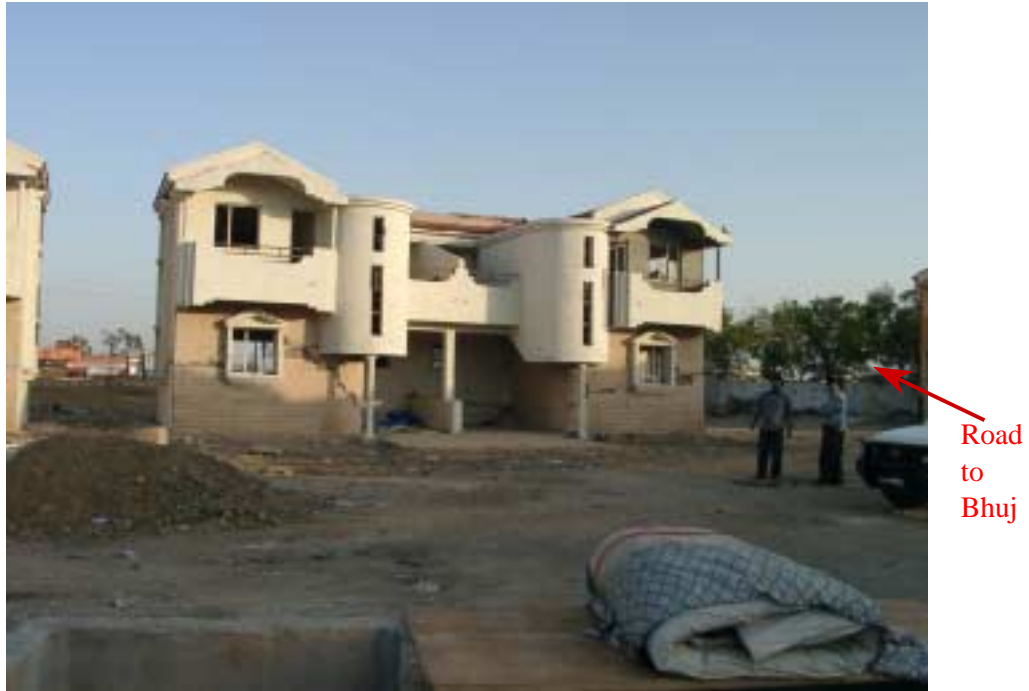
Figure 20. Severely damaged but still standing two housing unit block of the new housing complex shown in Figure 19. The small housing units are complete with parking lots, but the structural design does not seem to have considered seismic aspects. The bed seen outside is for the people guarding the property.

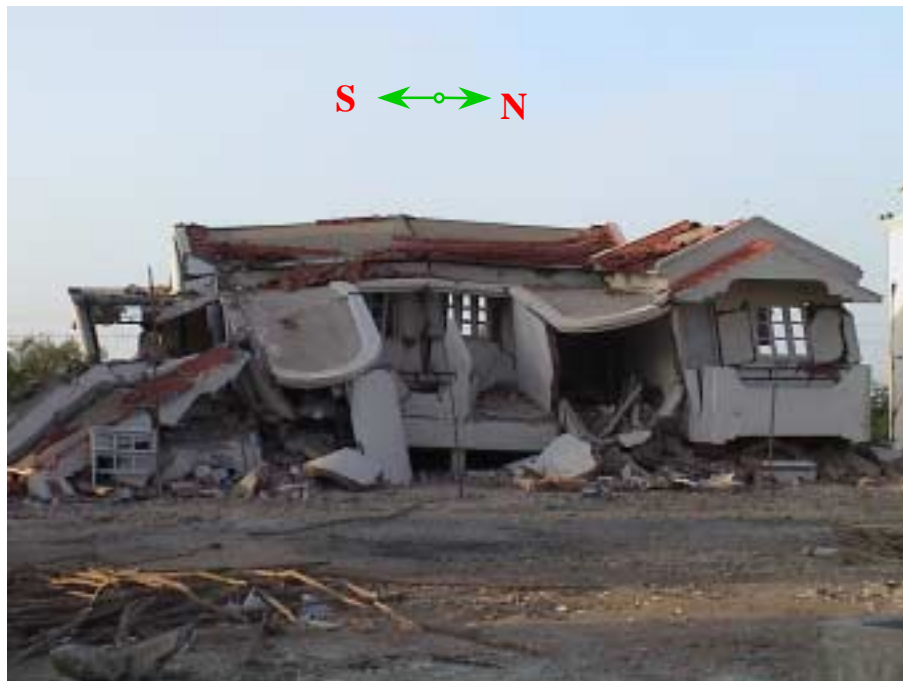
Figure 21. Completely collapsed block of two housing units similar to that shown in Figure 21. It had collapsed completely with large southward movement, which may be due to the presence of stronger north south motion this earthquake.

7. During field observation of damage to building structures, the authors noted frequent instances of significantly larger movement of damaged or failed structures in the north south direction. It is not possible to be conclusive, but it is possible that it may be due to stronger earthquake motion in the north south direction.

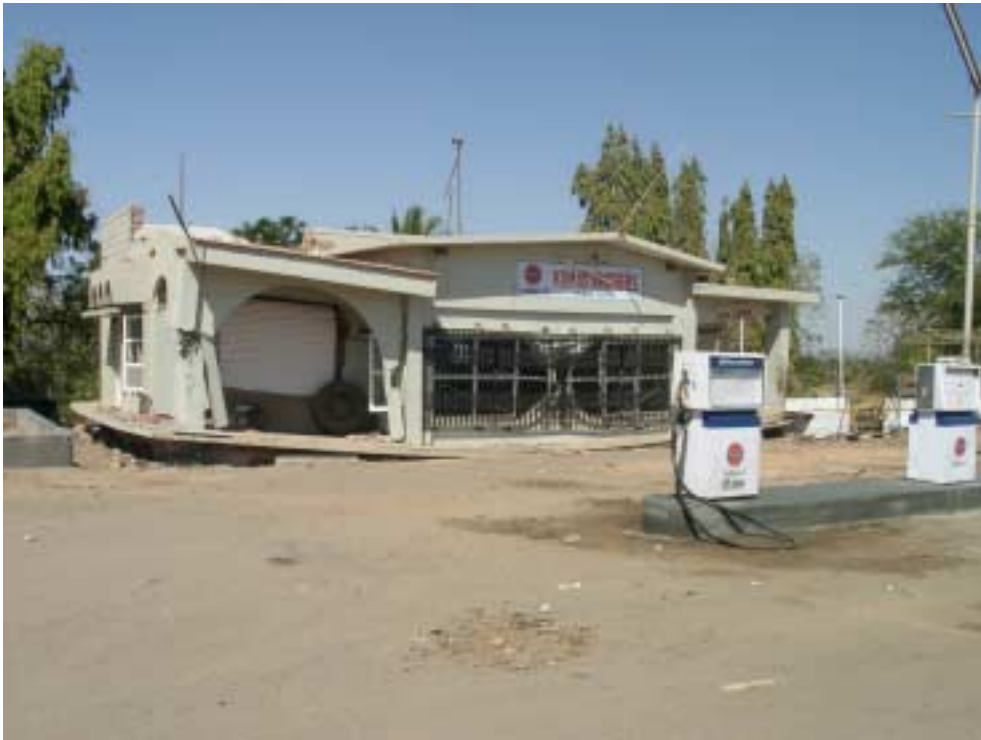
Figure 22. Collapsed office building of gasoline station near Bhachau. The gas station was in operation.

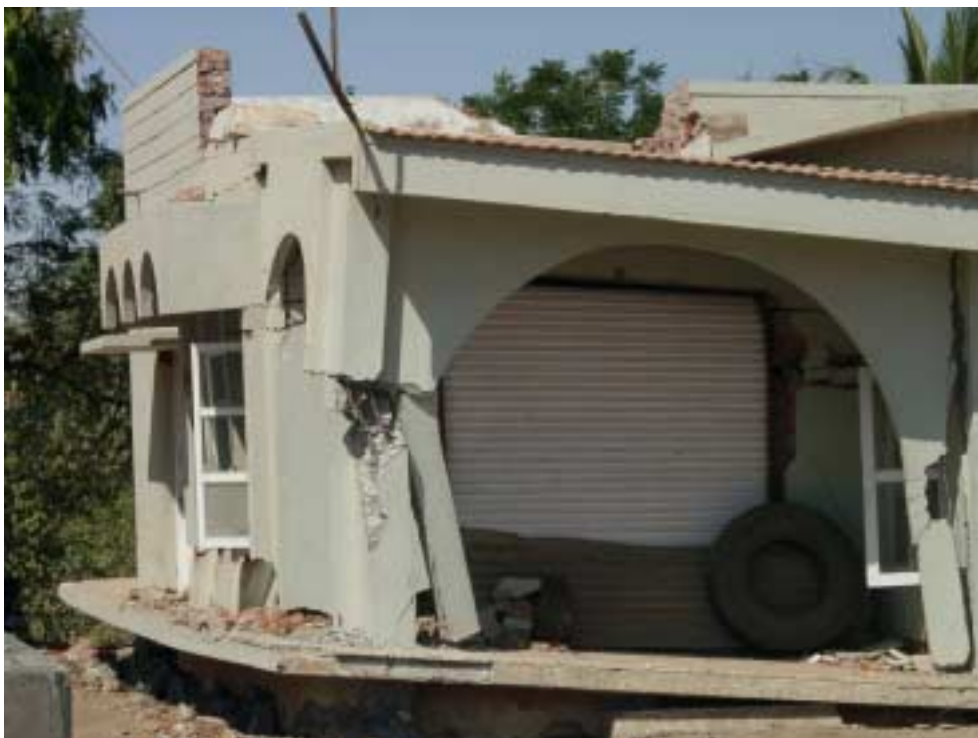
Figure 23. Closer view of the collapsed building of the gasoline station near Bhachau.

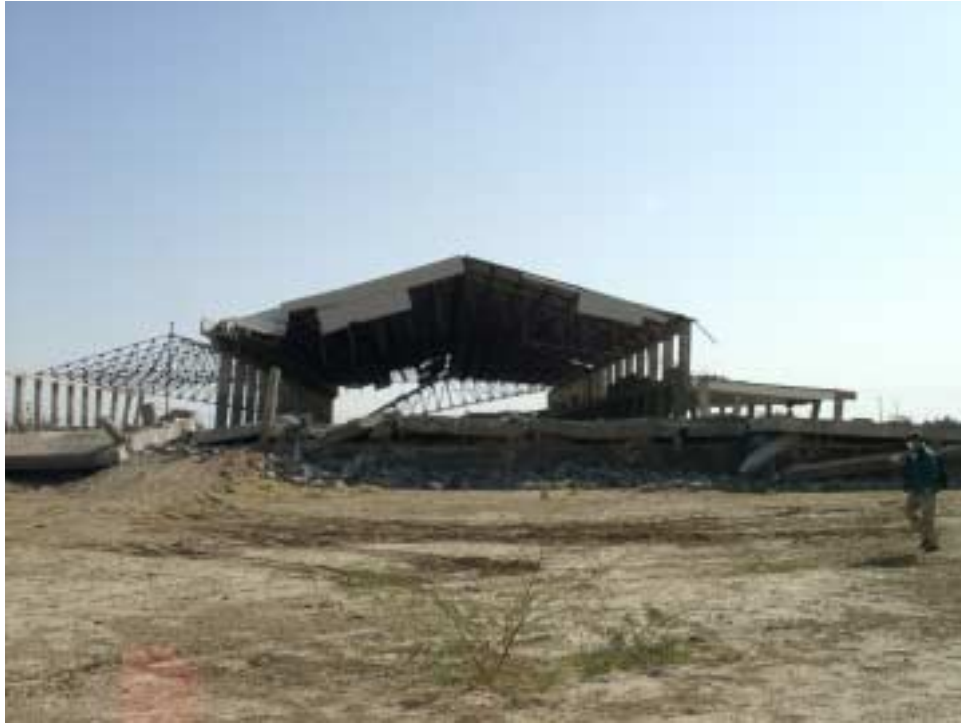
Figure 24. Collapse of the incomplete KC Polytec Ltd. factory building between Dagala and Madhapur, about 20km east of Bhuj. The building had collapsed with large southward movement.

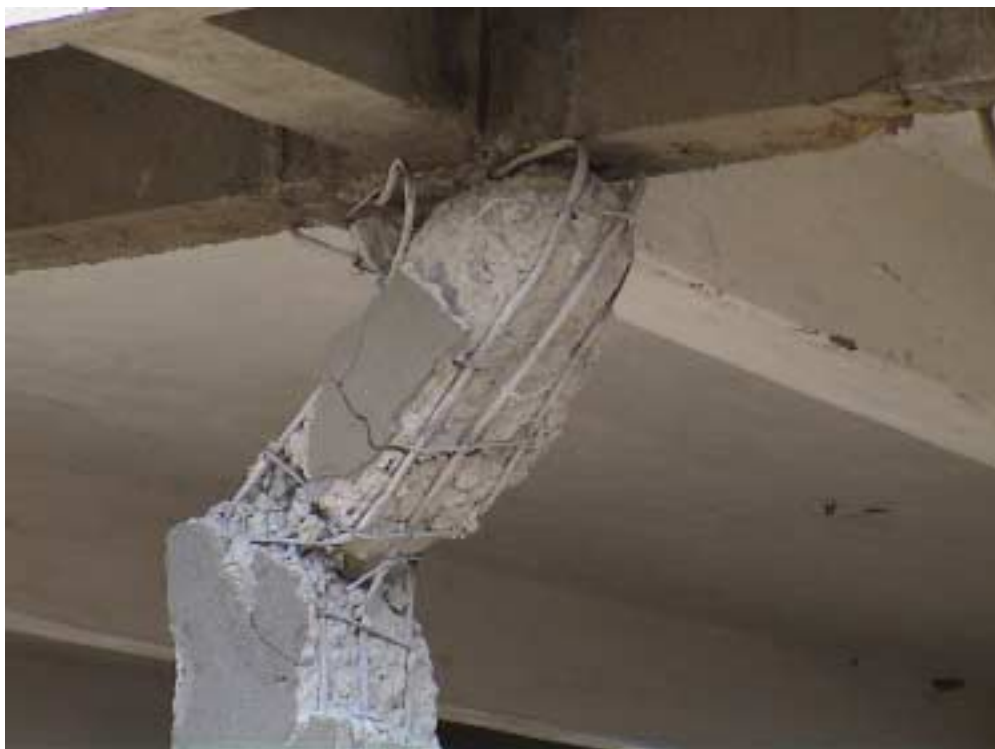
Figure 25. Close-up view of the top of concrete column supporting the factory building of Figure 24, showing the reinforcement details and concrete quality, and a substantial southward movement. The large southward movement may be due to stronger north south motion.

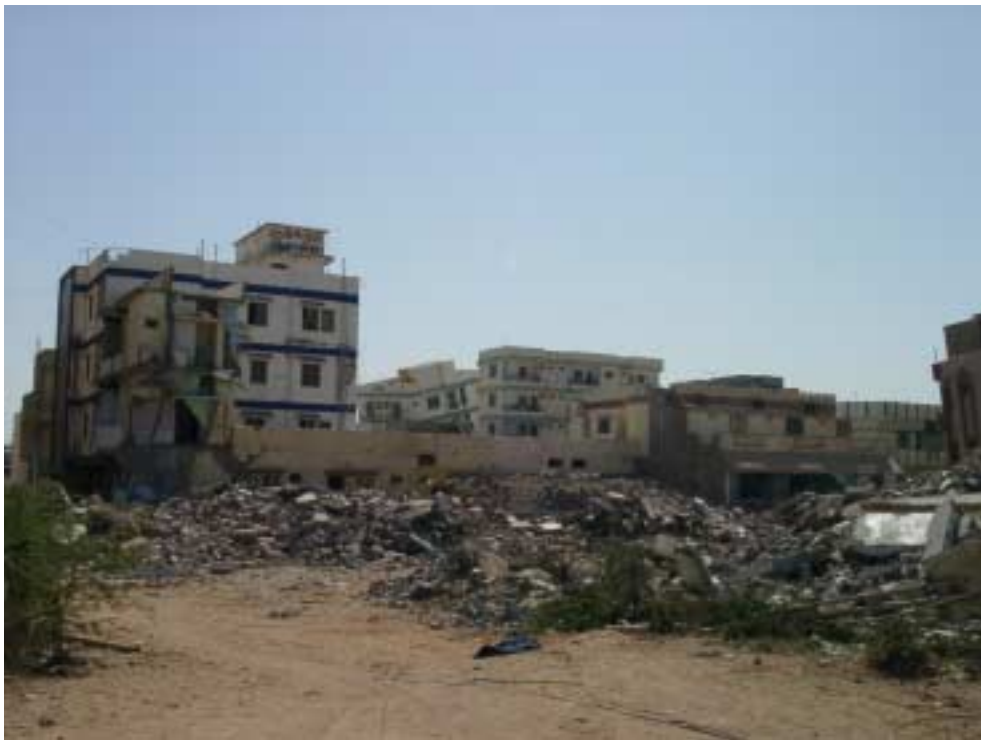
Figure 26. Buildings in different state of collapse and damage with wreckage dump in the foreground.

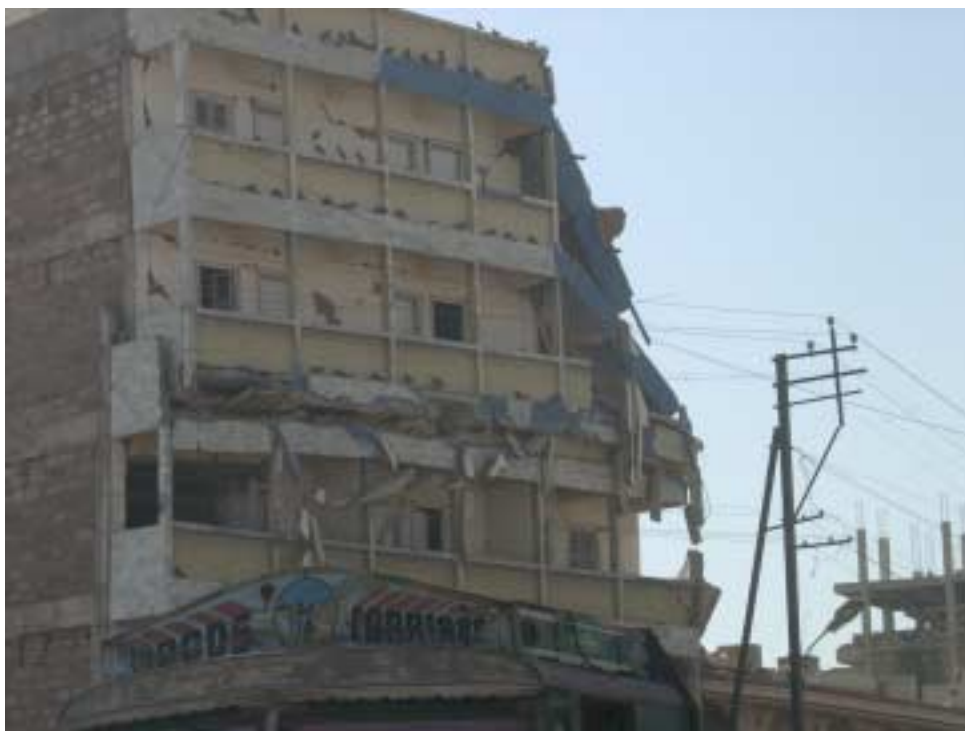
Figure 27. Partly collapsed massive concrete framed building structure with infill brick masonry walls.

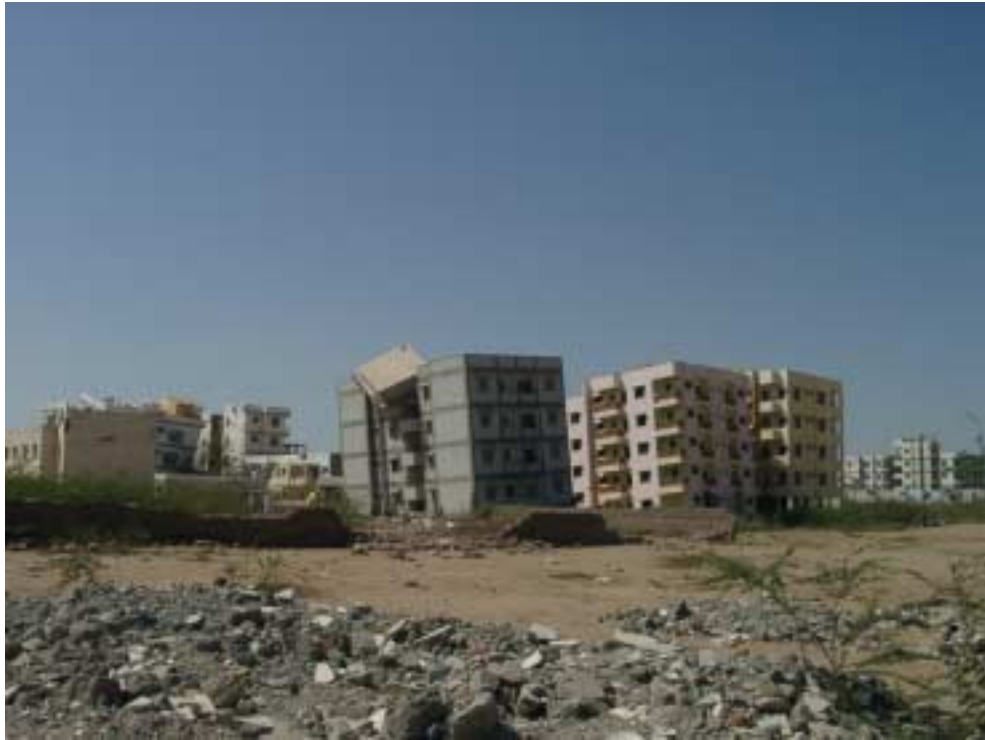
Figure 28. Group of damaged, tilted & partly toppled apparently relatively new apartment blocks in the central part of Bhuj. Damages to some of the buildings in the group seemed to be repairable.

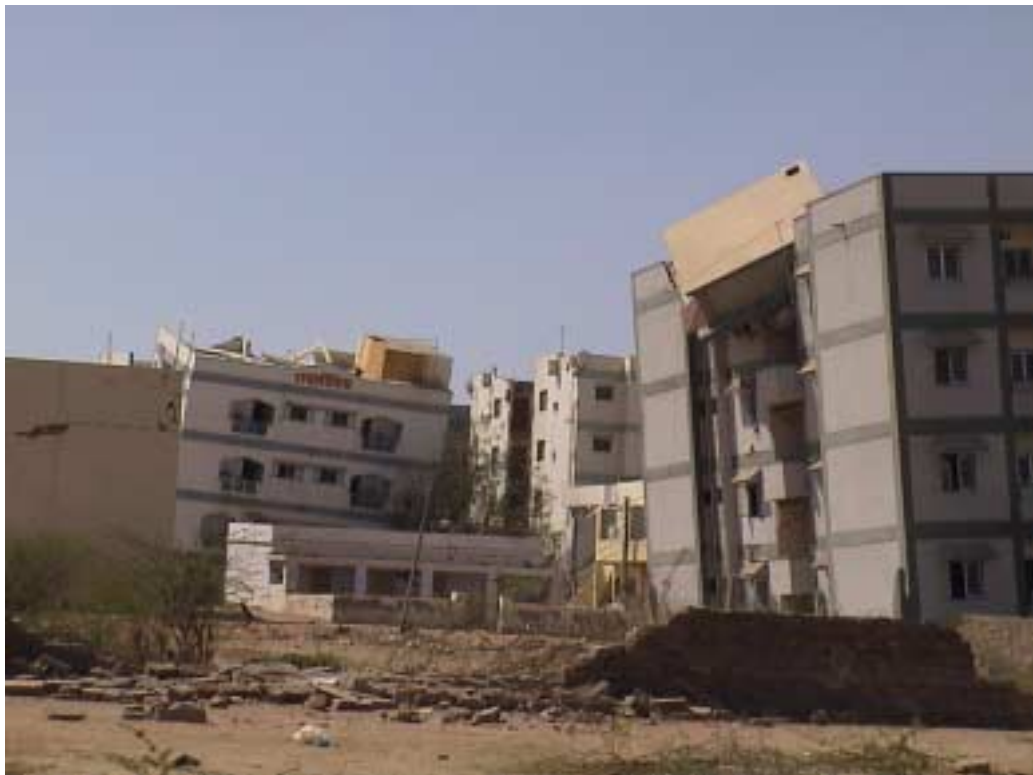
Figure 29. Close-up view of Figure 28 showing tilted buildings and toppled overhead water tank.

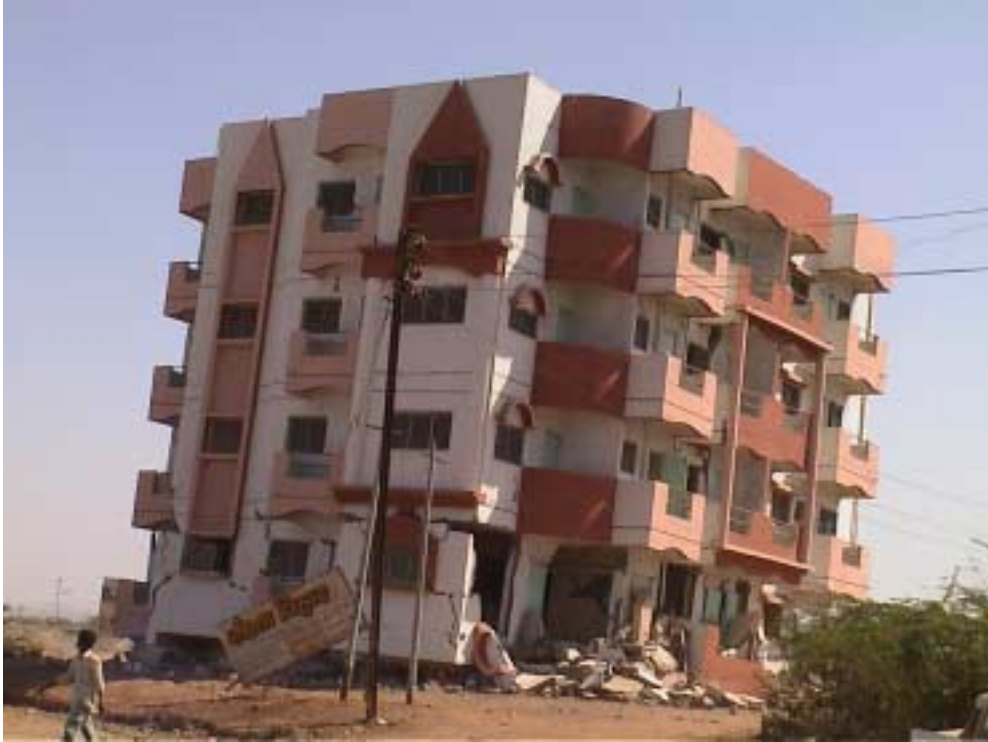
Figure 30. Apartment block consisting of reinforced concrete structure, severely tilted due to collapse of the first story. Apparently, the collapse resulted due to soft ground floor.

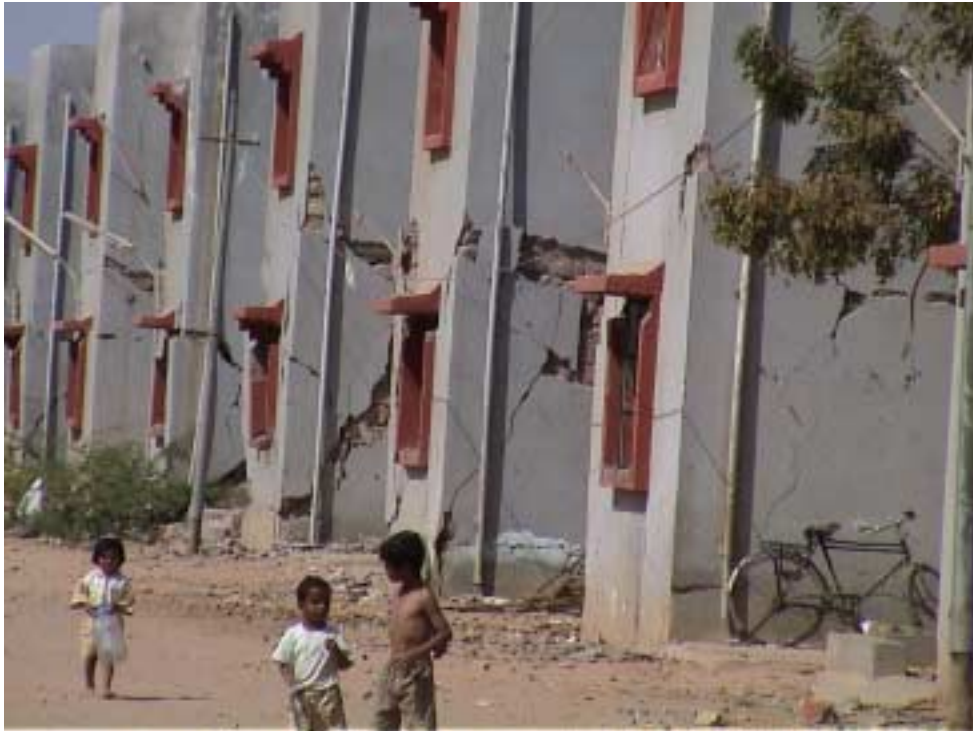
Figure 32. Closer view of the brick masonry housing units seen in Figure 31. Although severely cracked, the brick masonry housing units seem to have been kept from complete collapse.

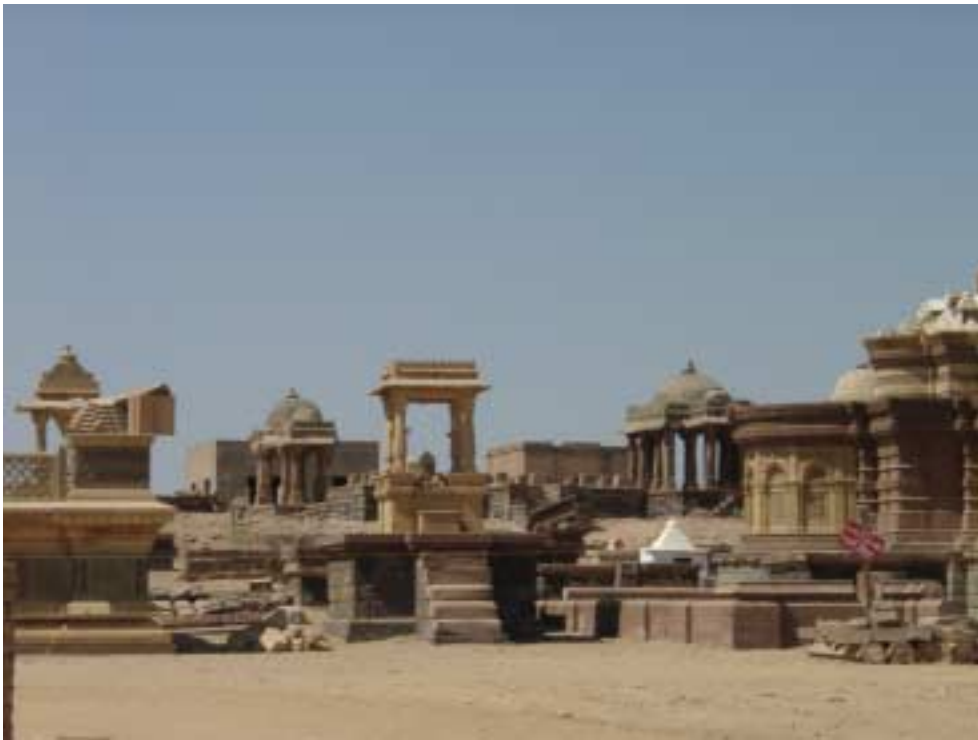
Figure 35. Closer view of the damage to holy burial ground for kings and queens from early days, allegedly from over 200 years ago.

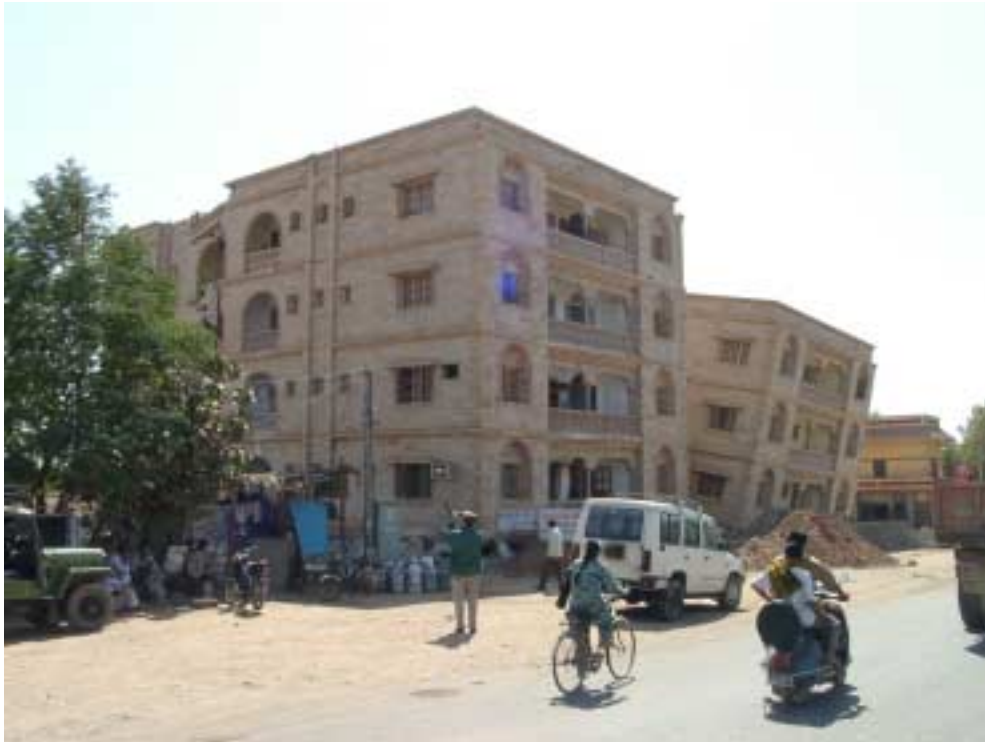
Figure 36. Overall view of the collapsed first story and tilting of relatively new concrete buildings with open space in the ground floor for shops and the like, creating a soft ground floor.

5. A significant portion of the failure of several storied reinforced concrete buildings resulted from the collapse of soft ground floor. In most cases, the upper floors of these buildings remained intact because of the effect of added lateral stiffness due to presence of masonry infills, when compared to the open ground floor. The benefit of energy absorption mechanism from failure of ground floor, may have inadvertently served as a seismic isolator to keep upper floors intact.

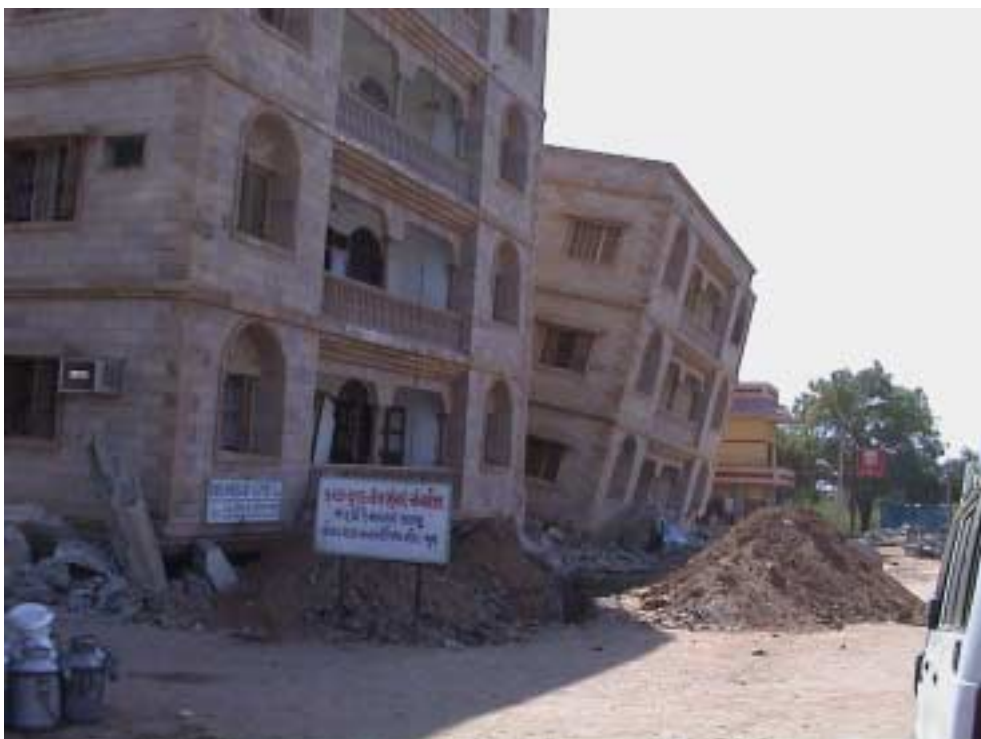
Figure 37. Closer view of collapsed ground floor with store front sign boards sitting on the floor.

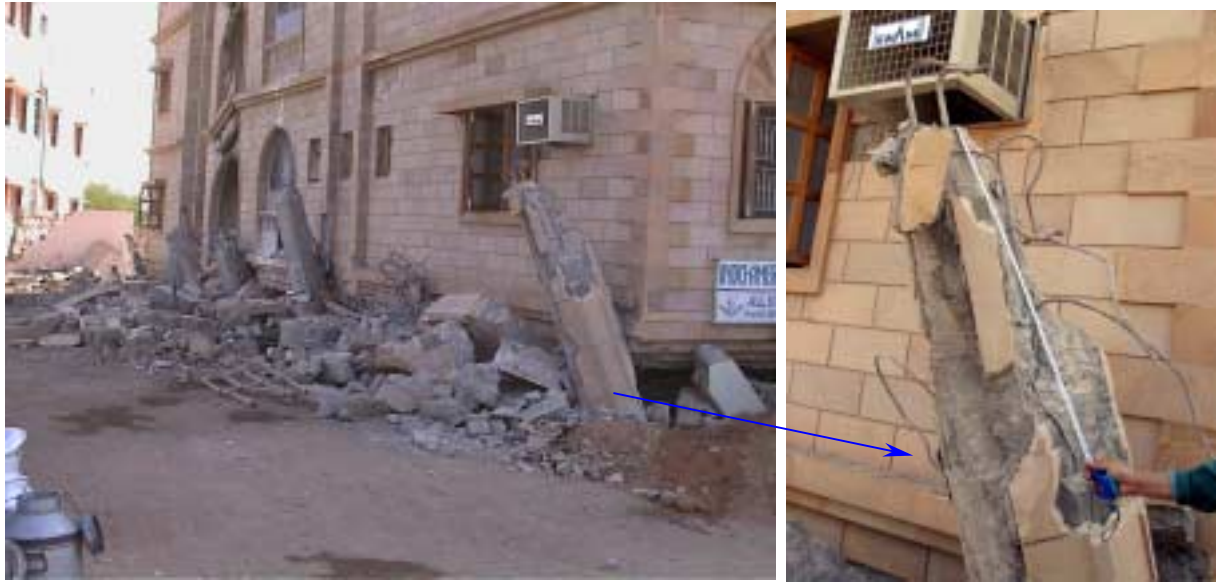
Figure 38. Close-up view of the nature of failure in the ground floor reinforced concrete columns together with a magnified view of column reinforcement with deficient lateral ties for confinement. Also the presence of aggregate in the concrete was difficult to discern.

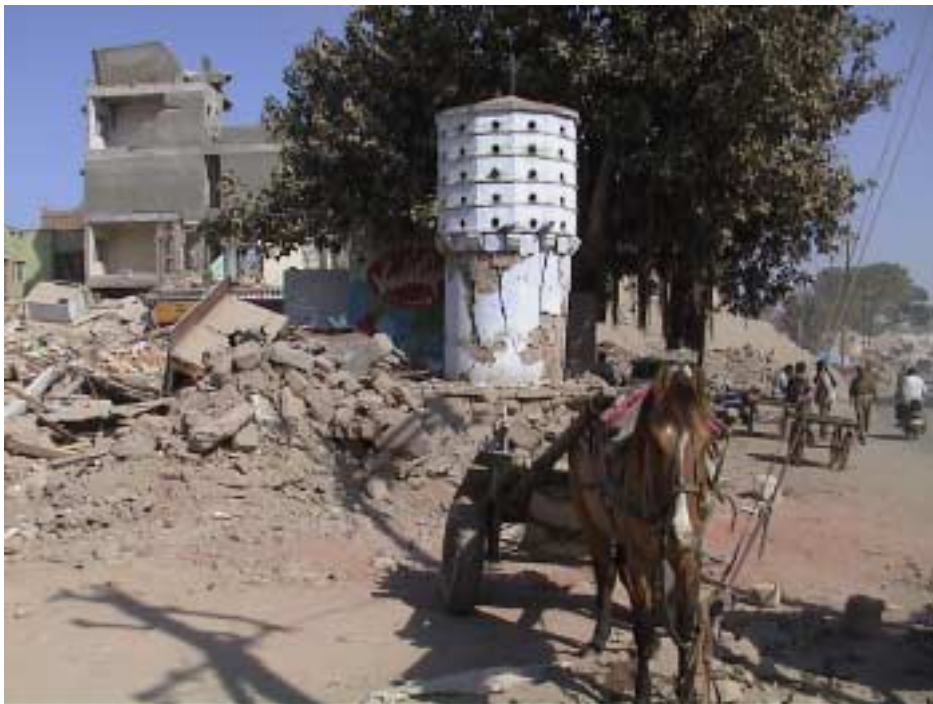
Figure 39. Badly cracked but standing pigeon house in the midst of total devastation of human habitation all around in Anjar. The supporting structure of pigeon house consists of masonry in mud mortar.
