PRELIMINARY OBSERVATIONS ON DAMAGE TO BUILDINGS IN GUJARAT (WESTERN INDIA) EARTHQUAKE OF JANUARY 26, 2001

Madan B. KARKEE

Naoyuki ITAGAKI

ABSTRACT: About three weeks after the Gujarat earthquake, the authors were deployed by the Department of Architecture and Environment, Akita Prefectural University, to undertake a preliminary assessment of the nature of damage to buildings in some of the affected areas of Gujarat. The trip was organized over a very short period and without any detailed planning and without benefit of adequate prior information about field conditions in the earthquake aftermath. Actually, primary objective was to gather the basic necessary factual information about the actual situation in the affected region, based on which other institutions in Japan may be able to organize teams of engineers for more detailed investigation. Further, considering the relief work that was expected to be in full force, the field observations were kept as unintrusive as possible. This report attempts to summarize some preliminary observations based on the field trip by the authors, and mostly consists of photographs of damaged buildings.

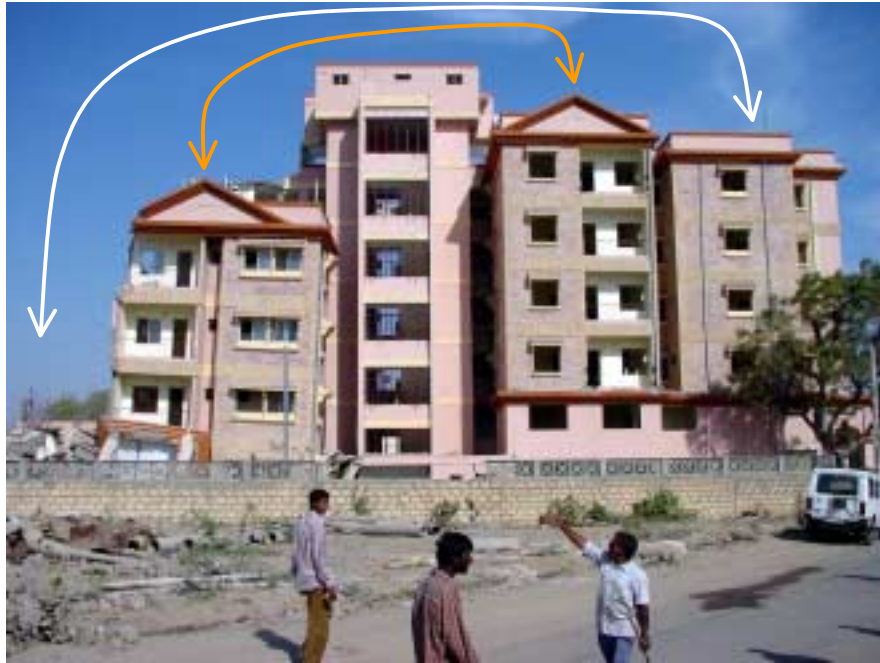
Figure 40. Partly collapsed and badly damaged new reinforced concrete building in Anjar just opposite (to the north) of the pigeon house shown in Figure 39. It seemed the building was designed to be more or less symmetrical on both sides of the stairs at the central part.

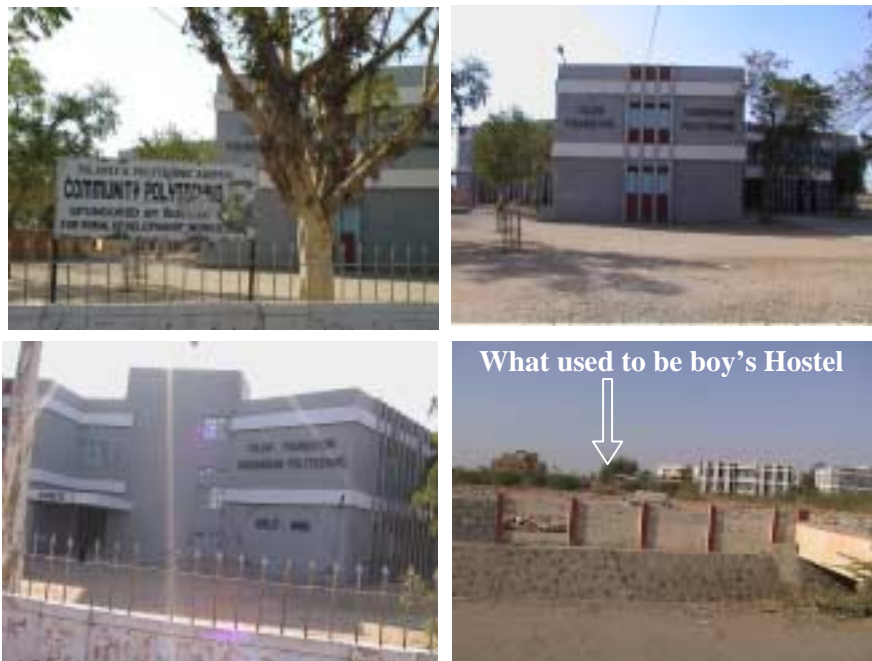
Figure 40. Damage and disruption at the polytechnic in Adipur where the girl's wing survived with severe cracking, but the collapse of boy's hostel resulted in a very large casualty.

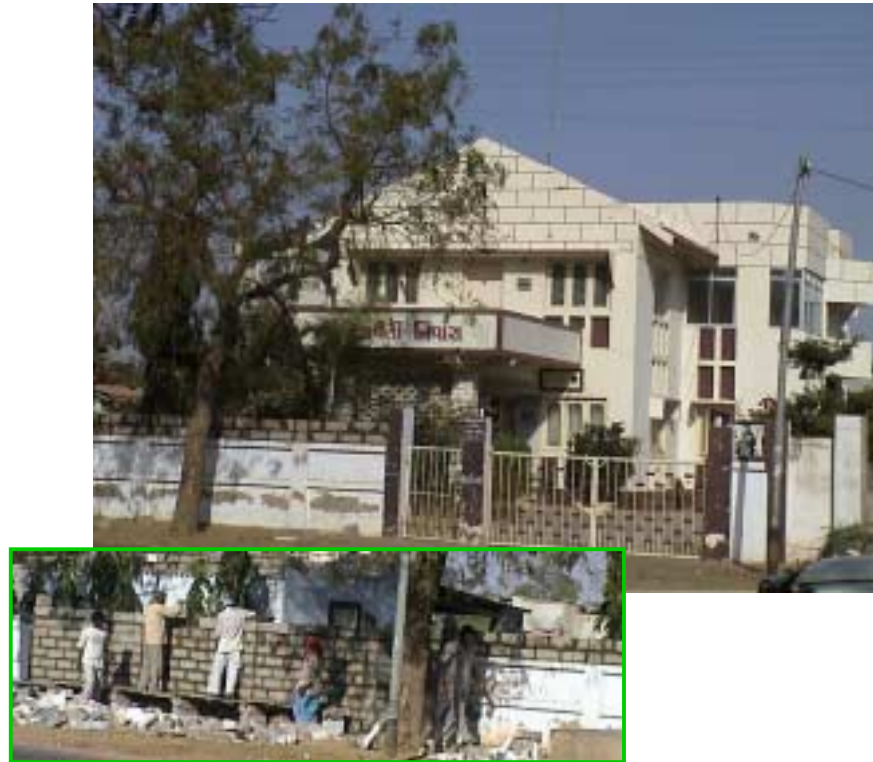
Figure 41. Apparently undamaged residential building adjacent to the community polytechnic, where the repair of the collapsed boundary wall (inset) was in progress to the left of entrance gate.

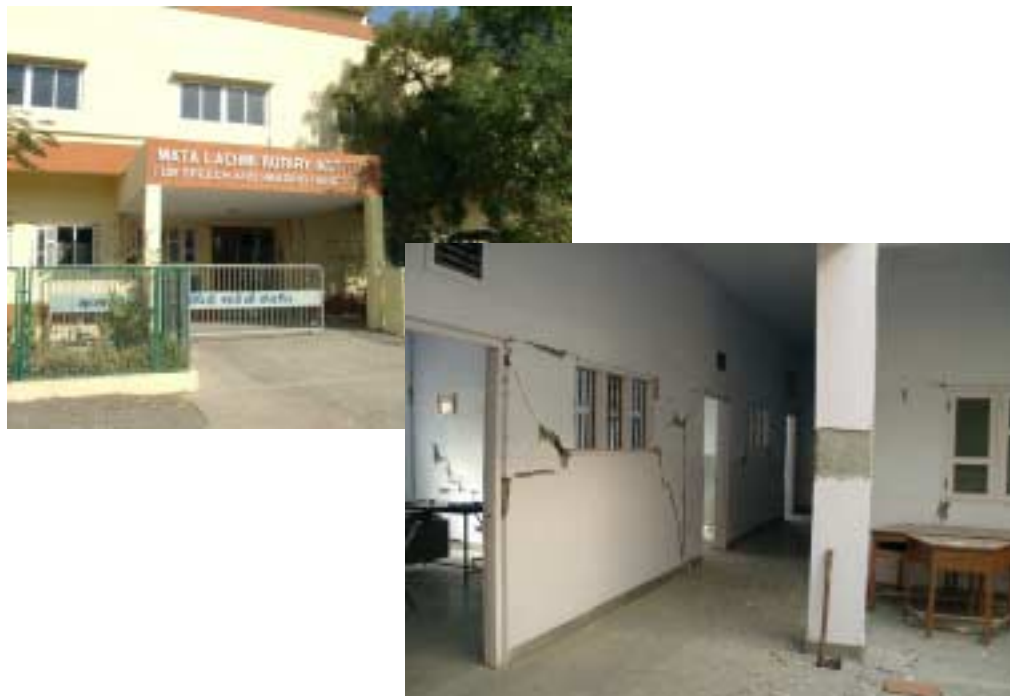
Figure 42. Frontage and the inside of Rotary institute for speech and hearing handicapped. The institute was closed after the earthquake, but the director who was kind enough to guide the authors the inside was planning repairs. Mostly, the damage seemed repairable.

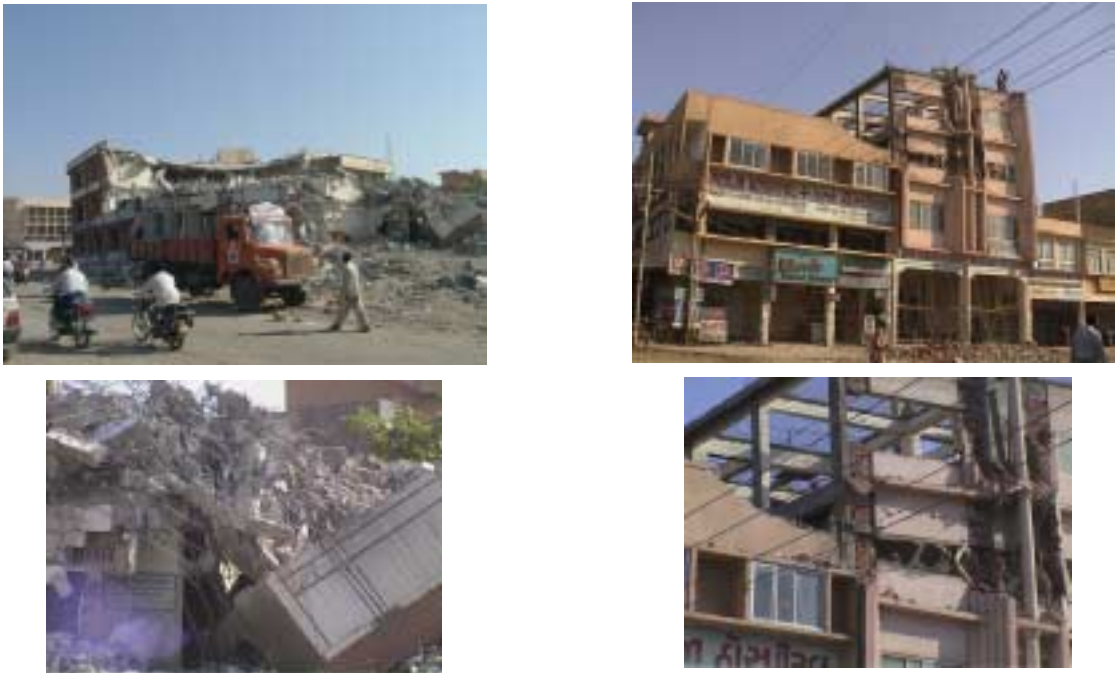
Figure 43. Demolition & removal of wreckage (left) and manual demolition in progress of a damaged hospital building with mid-floor collapse in Gandhidham. Clear separation of concrete & steel in the reinforced concrete wreckage (left) and demolition with hand-held hammer by the man standing at the top (right) provide some indication of the quality of materials used.

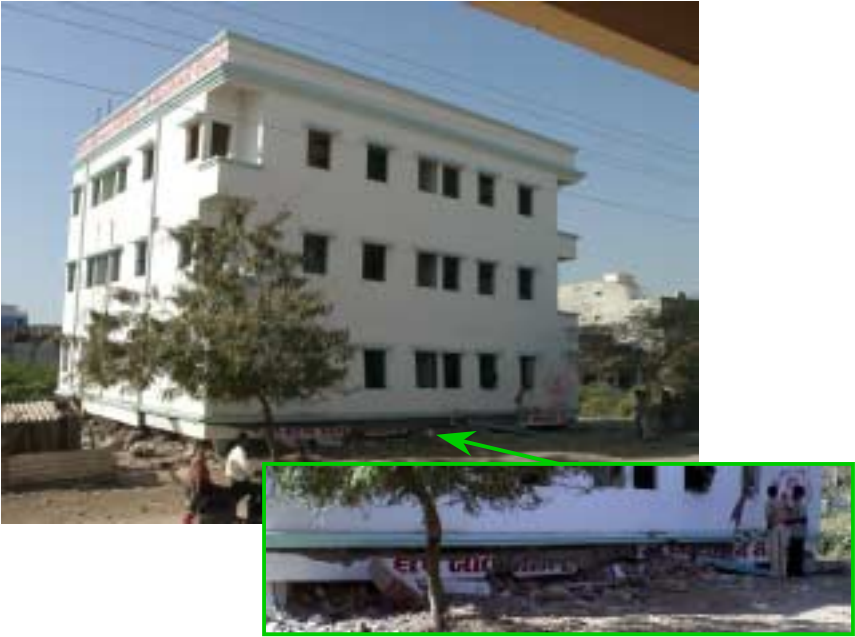
Figure 44. Collapsed ground floor (inset: close-up view) of Children’s Hospital and Research Center in Gandhidham, indicating a typical nature of soft ground floor failure.

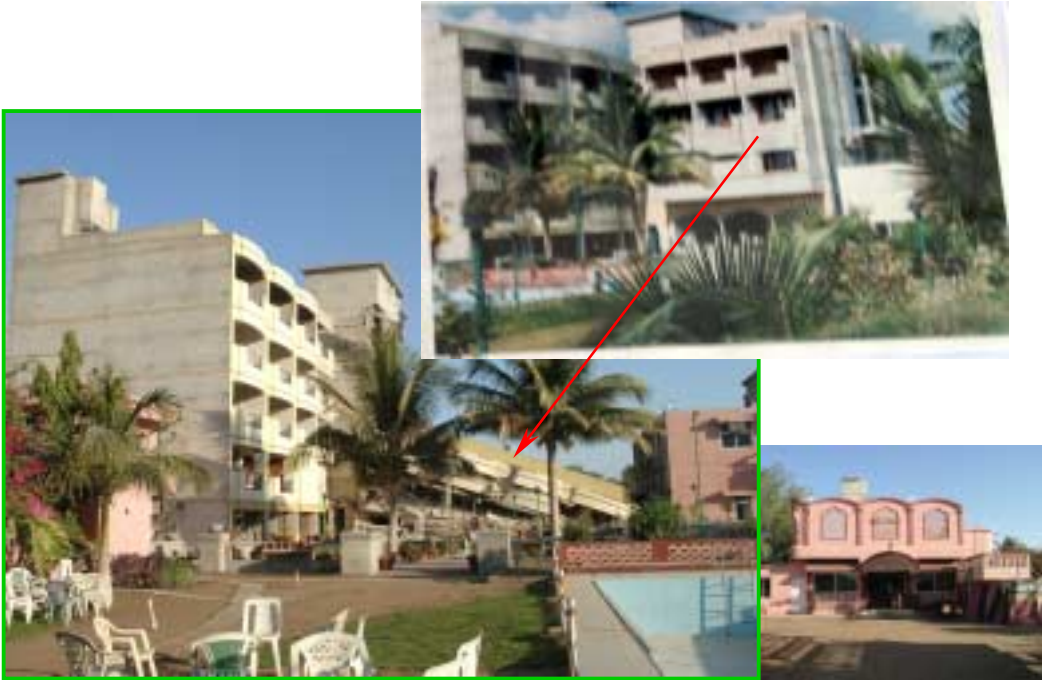
Figure 45. The collapsed wing of the luxury resort that was still in business, where authors spent overnight. The top inset is a photograph taken from the photograph the owner was kind enough to show to the authors and shows how the building looked before collapse. The inset to the right is the entrance to the reception area.

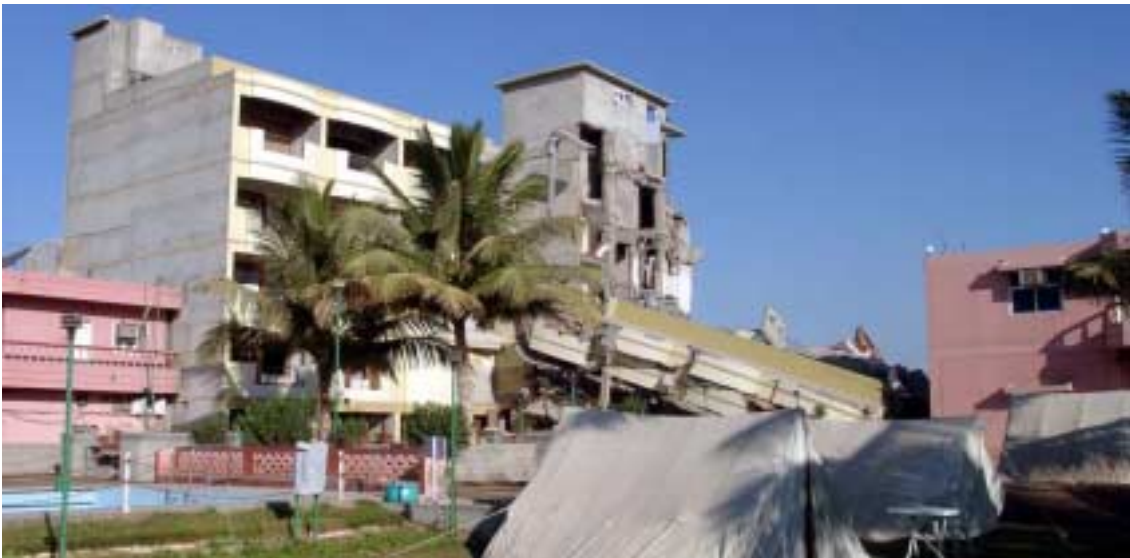
Figure 46. Closer view of the collapsed wing at Sharma Resort. Tents in the foreground were arranged by the owner for renting to the prospective customers. Some of rooms in the blocks that had not collapsed were also available for renting. The authors opted for the tent.

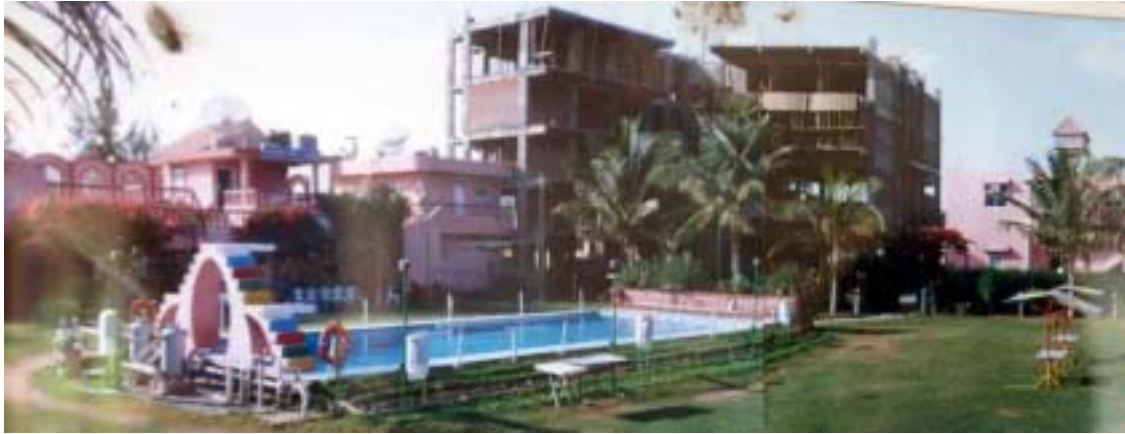
Figure 47. View of the collapsed block at Sharma Resort during construction. Again a photograph from the picture the owner kindly showed the authors. It is clear that the building consisted of reinforced concrete frame structure with infill brick masonry wall. This system of construction is typical of the reinforced concrete buildings in the region.

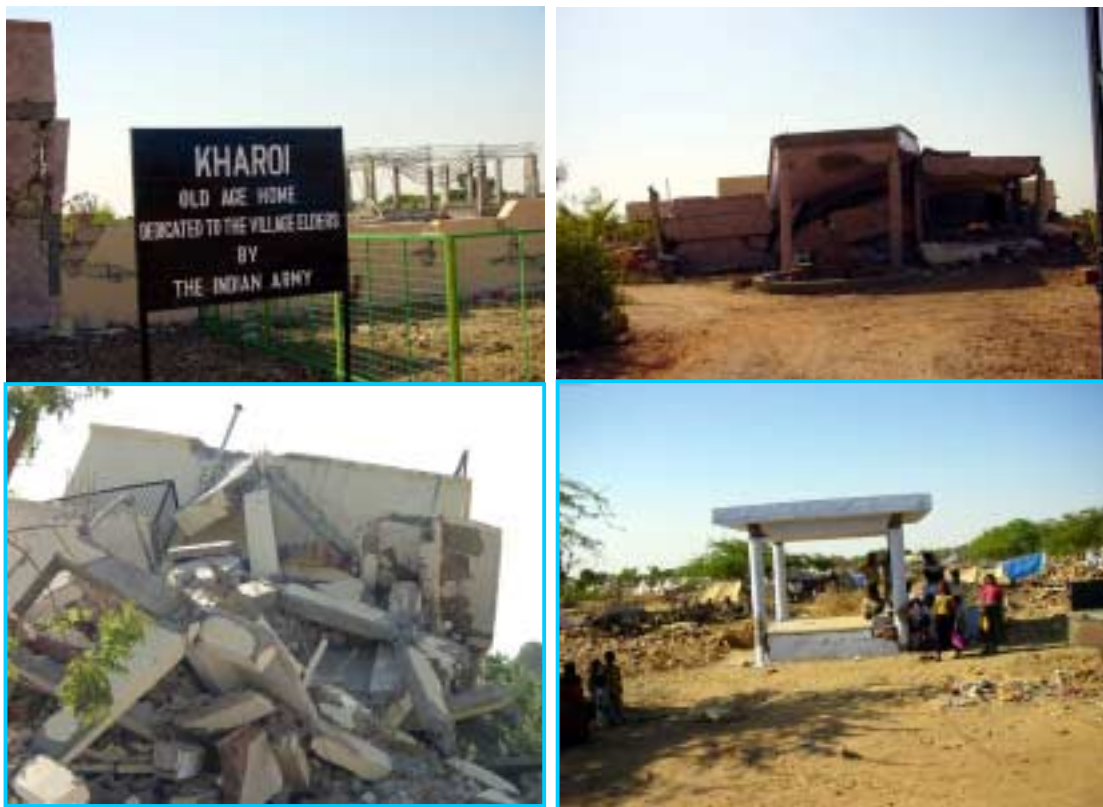
Figure 48. Damage scenes from the Chaubari area, to the east and close to the probable epicentral area. The top two photographs are of the compound of the damaged old age home. Lower left shows the severe nature of damage to reinforced concrete building in Chaubari. The lower right photograph shows the surviving simple concrete structure of a resting place in the midst of a completely destroyed village in Chaubari area, seemingly consisting of non-engineered houses. The tents accommodate survivors can be seen in the background.
