Field Observations and Microtremor Measurements at Inca Historical Sites and Constructions in Peru

Akita Prefectural University
Faculty of System Science and Technology
Department of Architecture and Environment Systems

Honjo, Akita 2004

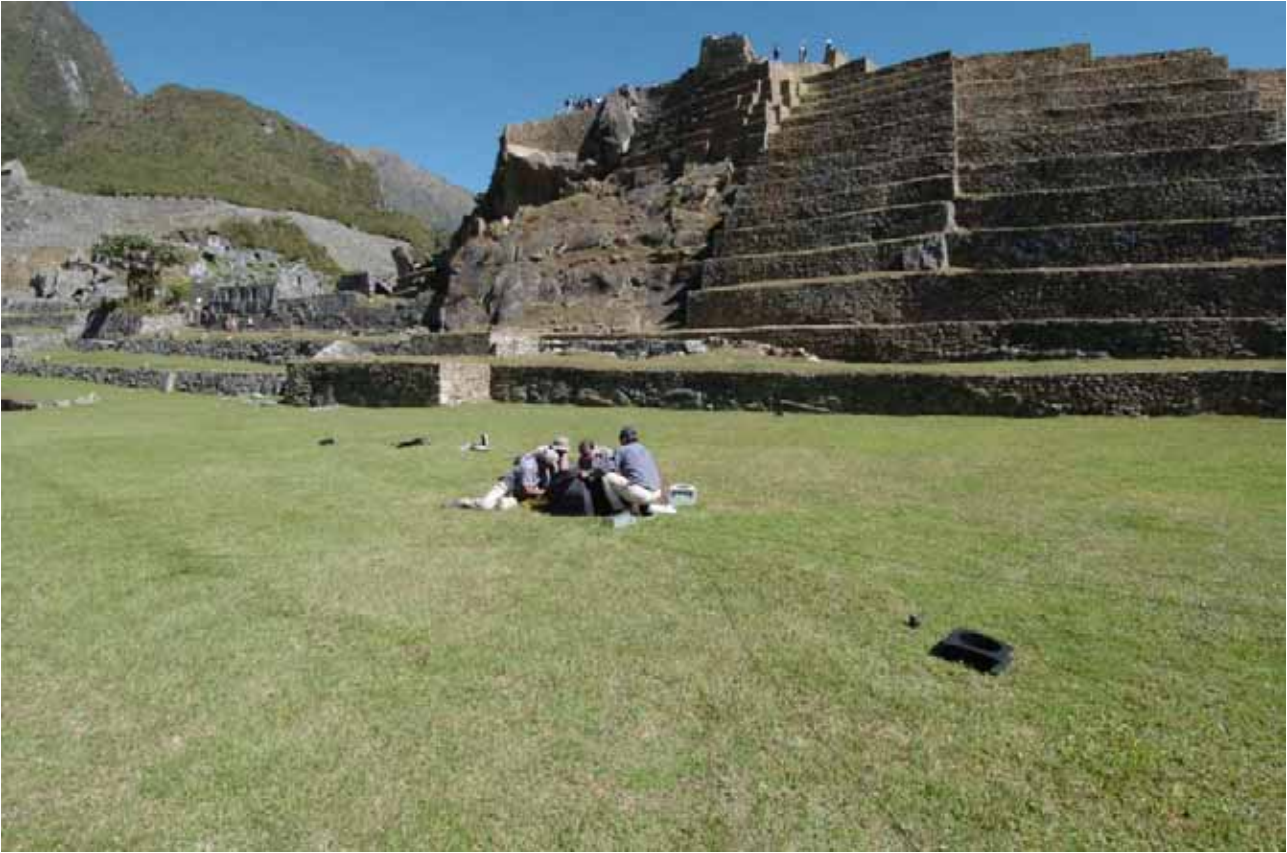
1.1. Plaza (square): Ground vibration measurement (vertical sensors)

At this site, measurements of the vertical components of the ground vibration were carried out. The sensors were laid in a triangular array system of 30 meter sides as shown in the figure below.

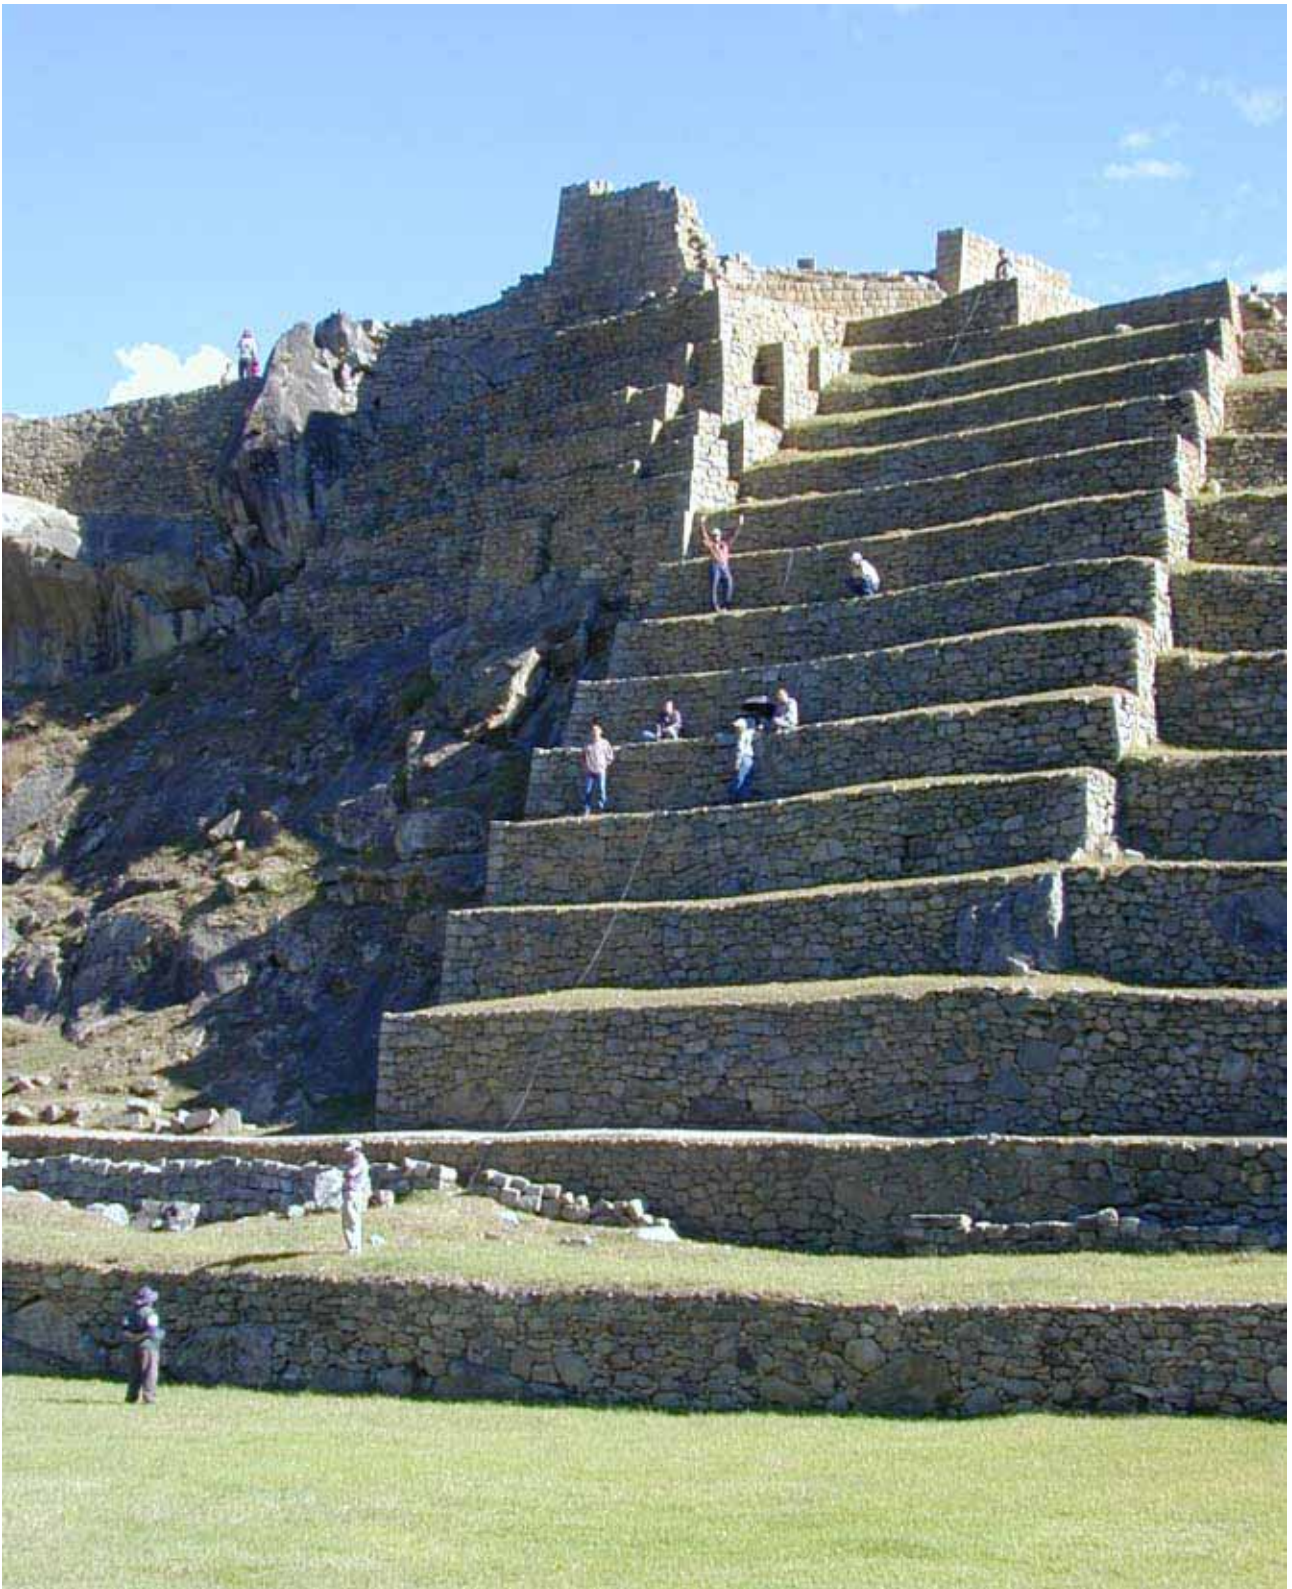
1.2. Terraces of Intihuatana: Vibration of terraces structures (horizontal sensors)

In this case, horizontal components of the vibration of the terraces were measured. North-South (NS) direction and East-West (EW) direction were measured separately. Sensors were located at top, intermediate and lowest part of the terraces. Next figures show the result of measurements for NS and EW directions respectively:

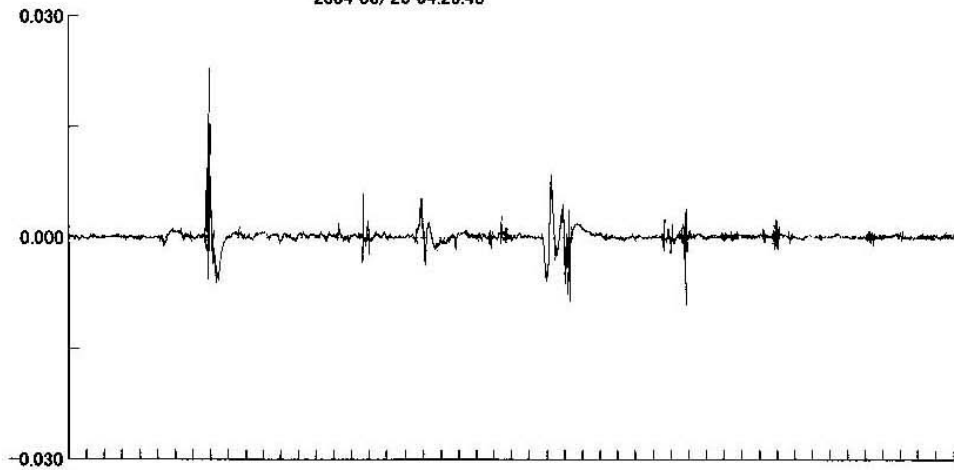
3 MACHUPICHU-TERRACE-INTIHUATANA-NS 04 06 20 04 23 48 04 06 19 14 23 48
2004 06/20 04:23:48

CH08:CH-8
Max. = 0.023 (kine)
Min. = -0.009 (kine)

CH09:CH-9
Max. = 0.003 (kine)
Min. = -0.002 (kine)

CH10:CH-10
Max. = 0.002 (kine)
Min. = -0.004 (kine)

CH11:CH-11
Max. = 0.009 (kine)
Min. = -0.002 (kine)
