### 1.3. Temple of Three Windows: Structure vibration

#### 1.4. Principal Temple: Structure vibration

## 1.5. Temple of the Sun: Structure vibration

### 1.6. Building No 7 of Group 2: Gable wall and structure vibration

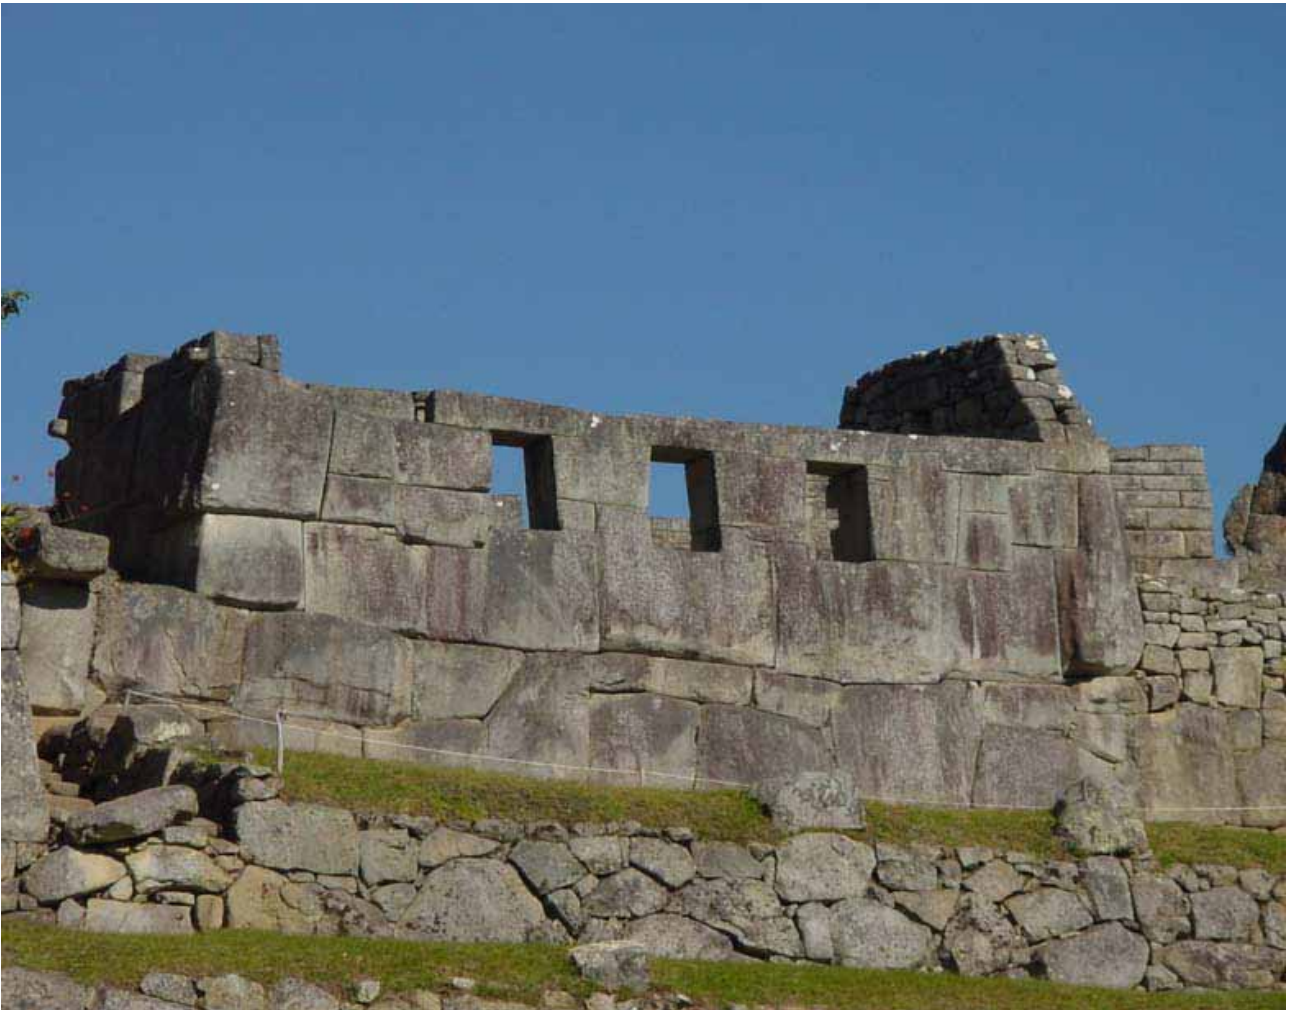
Horizontal components of microtremor were measured on the structure and over free field ground at this important part of the Machupicchu citadel. Two horizontal components in NS direction and EW direction were measured separately. Two sensors were located on the ground near the building, one in the external part and another one in the interior of the building. Also, one sensor was located on the central window and another one on the top of the building above the central window. The time domain plots of the measurements are given below.

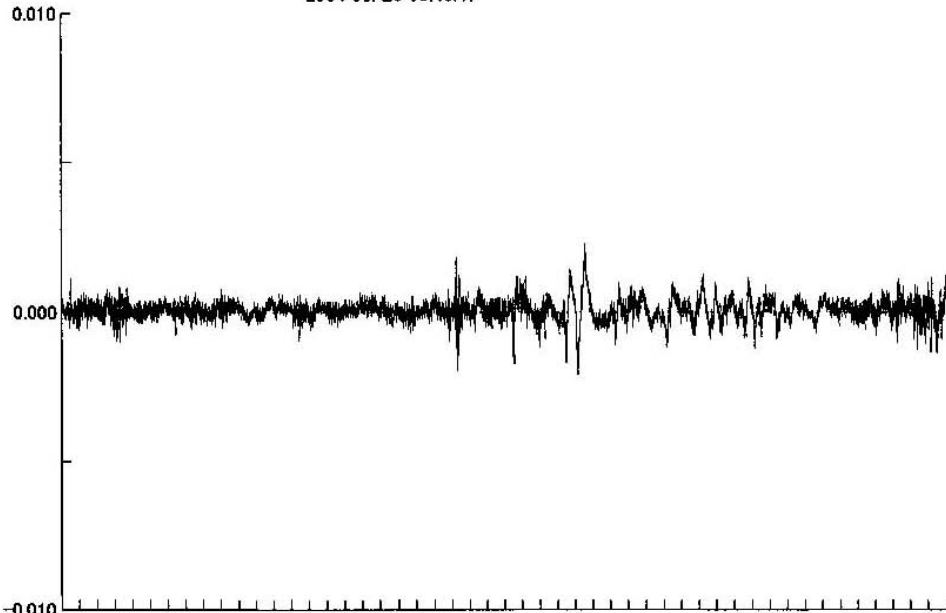
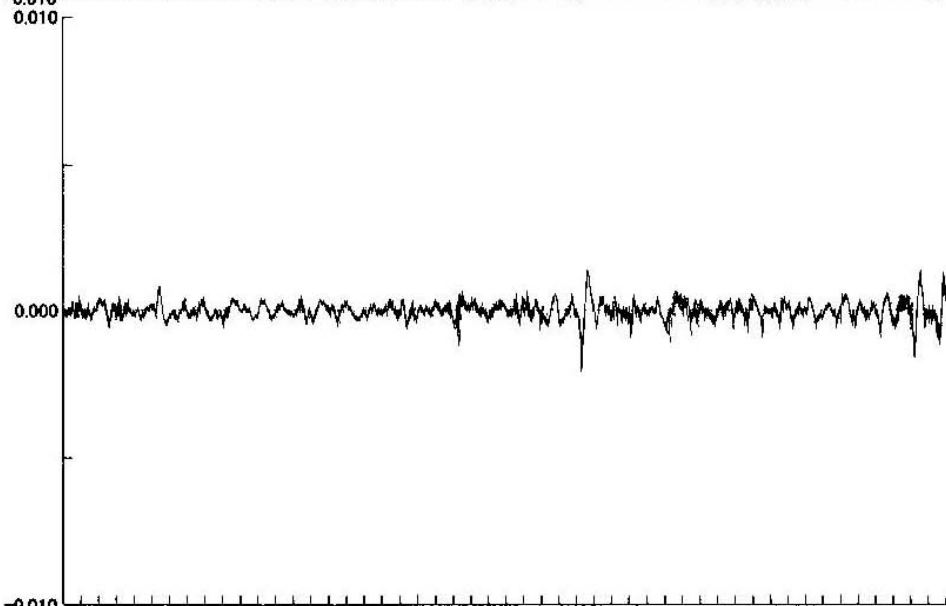
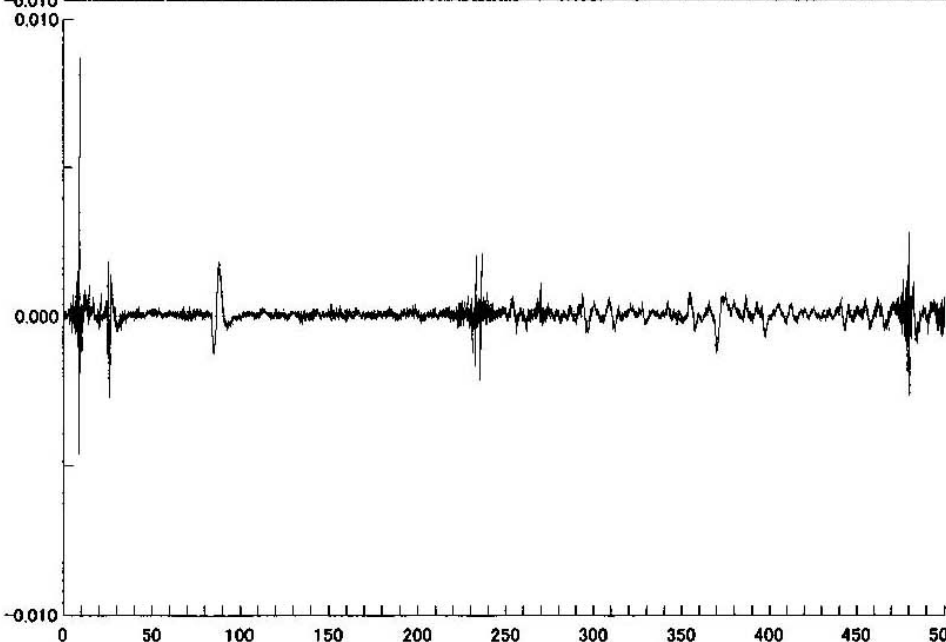
2004 06/20 05:43:47

CH07:CH-7  
Max. = 0.002 (kine)  
Min. = -0.002 (kine)

CH08:CH-8  
Max. = 0.001 (kine)  
Min. = -0.002 (kine)

CH09:CH-9  
Max. = 0.009 (kine)  
Min. = -0.005 (kine)

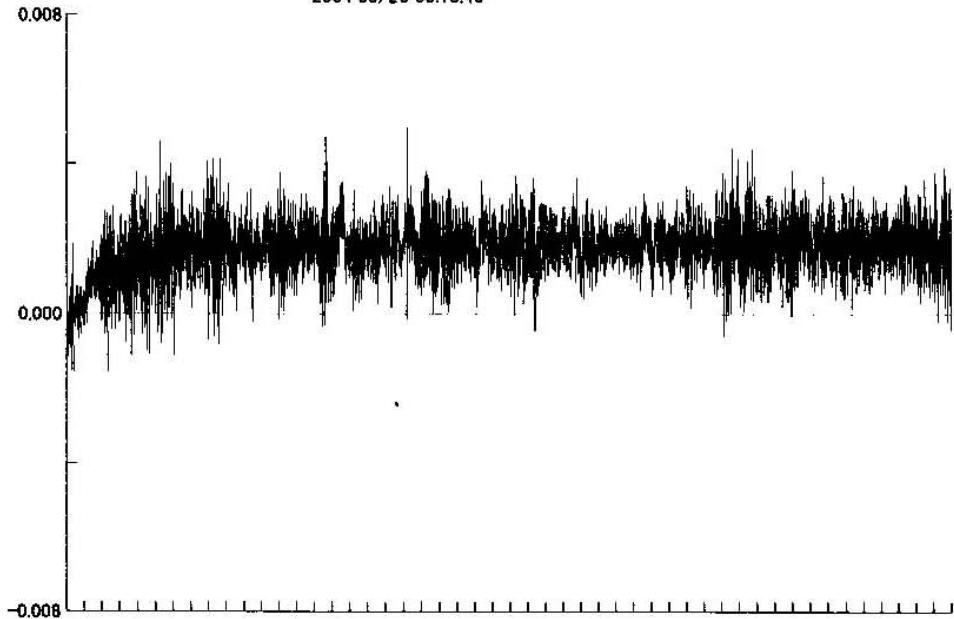
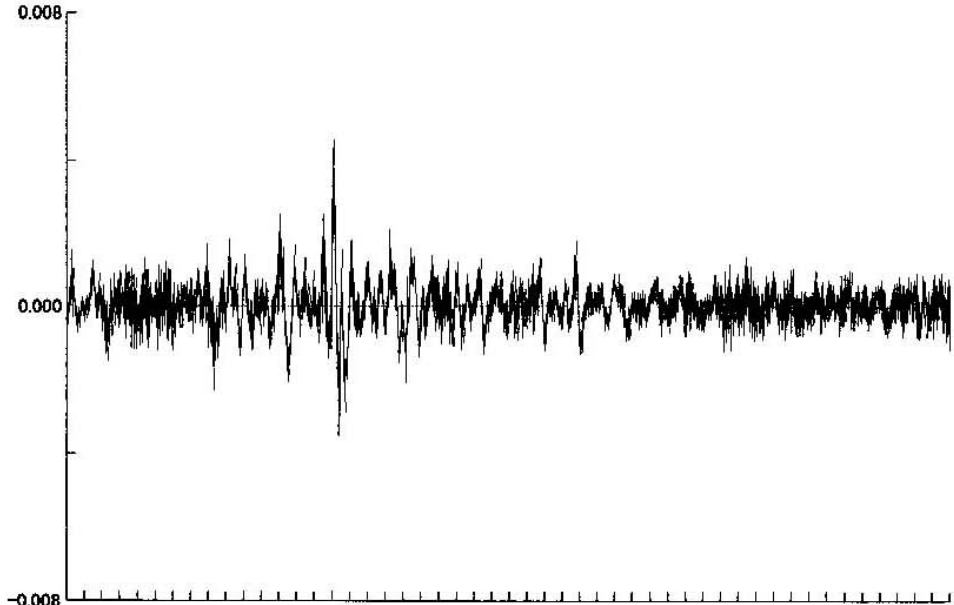
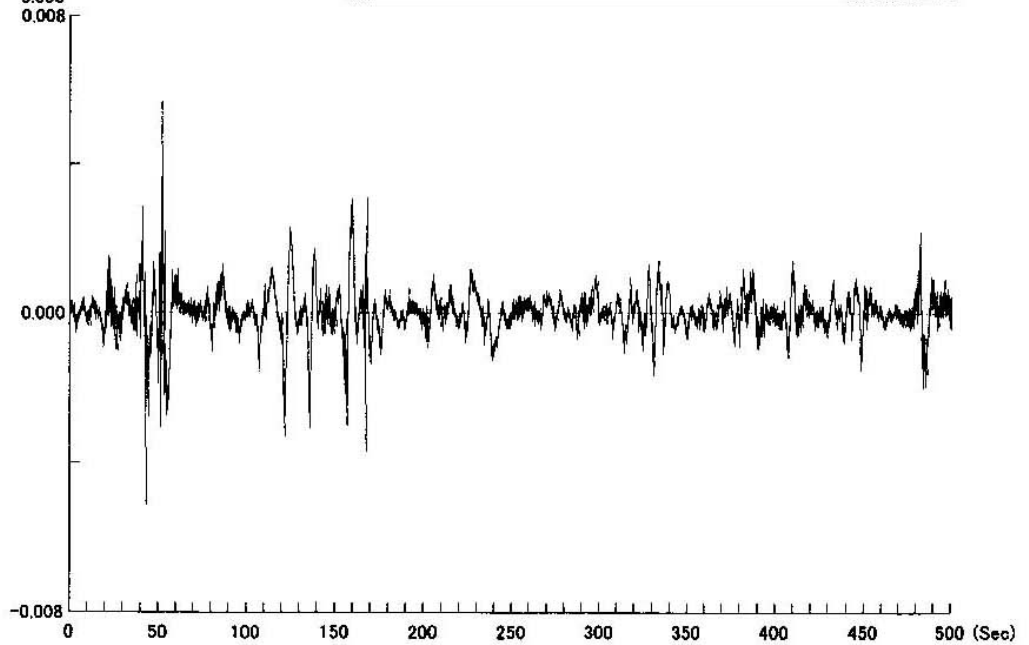
4 MACHUPICHU-3WINDOWS-EW

CH07:CH-7  
Max. = 0.005 (kine)  
Min. = -0.002 (kine)

CH08:CH-8  
Max. = 0.005 (kine)  
Min. = -0.004 (kine)

CH09:CH-9  
Max. = 0.006 (kine)  
Min. = -0.005 (kine)

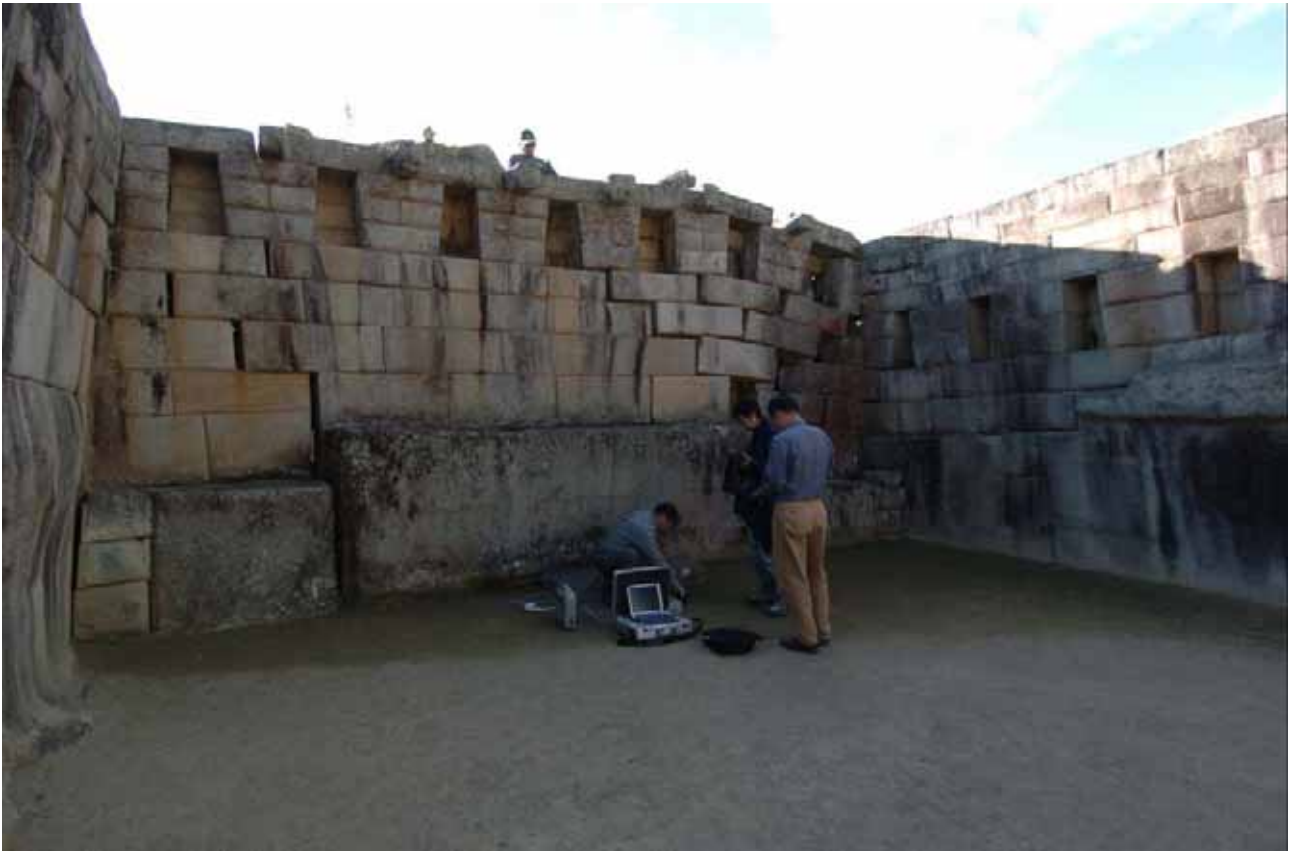
This structure shows evidence of ground settlement on its east wall (right hand side of the photograph). In this case the two horizontal components and the vertical component were measured at top of the wall and at ground level. The time domain plots are given below. The first three channels correspond to measurement on top of the wall while the last three channels are the three components over the ground.

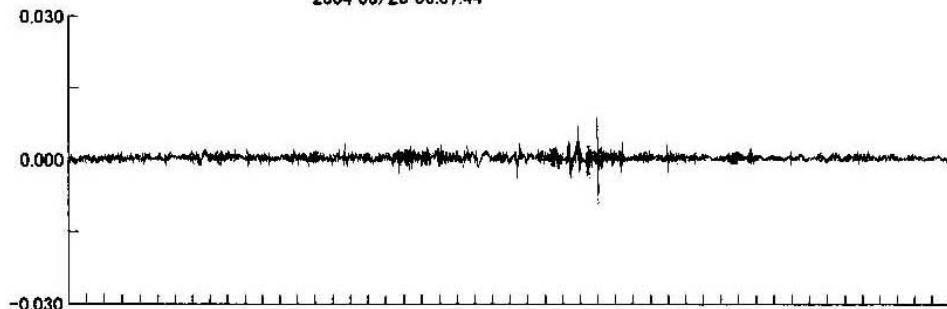
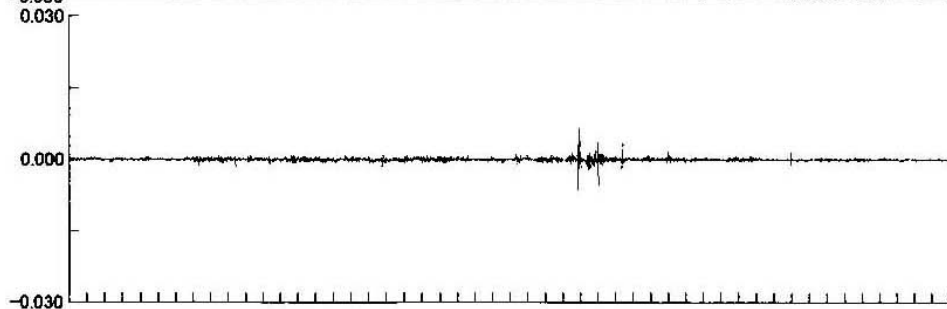
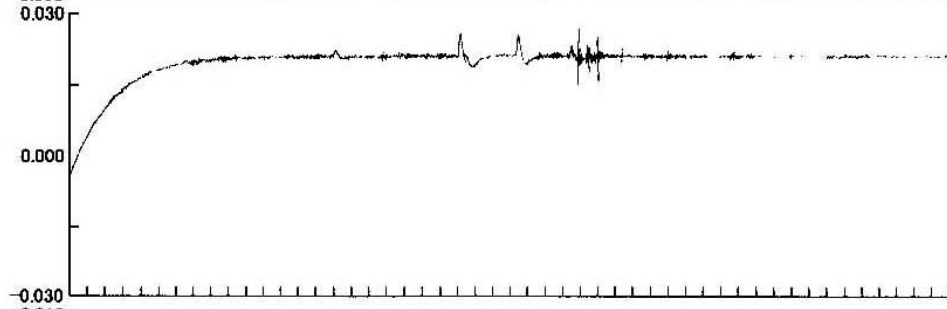
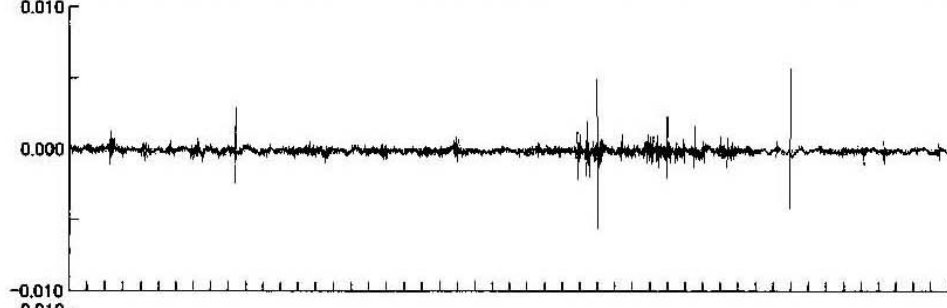
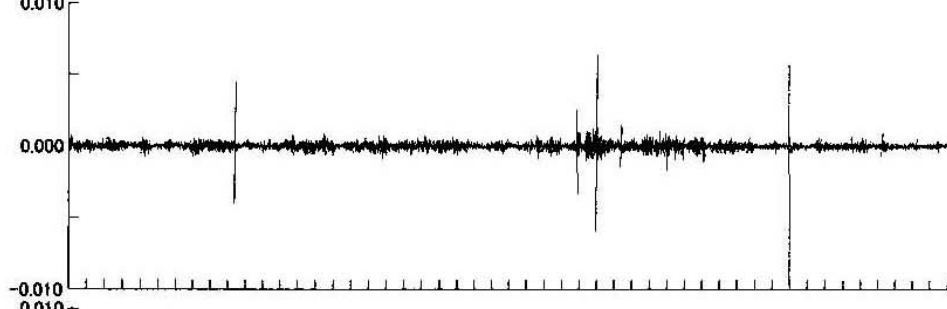
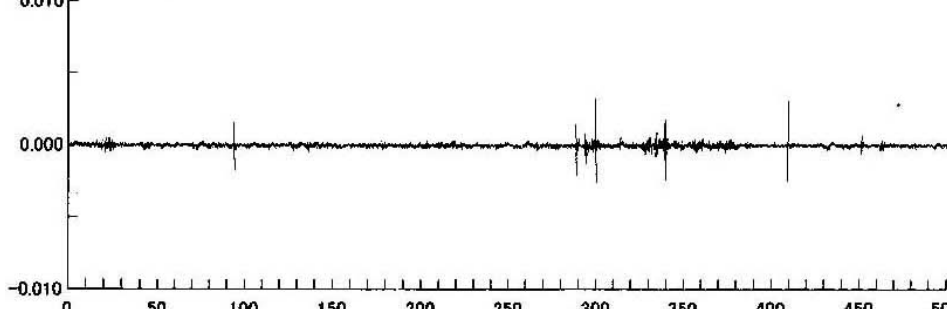
6 MACHUPICHU-MAIN-TEMPLE-3comp

CH07:CH-7  
Max. = 0.009 (kine)  
Min. = -0.010 (kine)

CH08:CH-8  
Max. = 0.007 (kine)  
Min. = -0.007 (kine)

CH09:CH-9  
Max. = 0.027 (kine)  
Min. = -0.005 (kine)

CH10:CH-10  
Max. = 0.006 (kine)  
Min. = -0.006 (kine)

CH11:CH-11  
Max. = 0.006 (kine)  
Min. = -0.010 (kine)

CH12:CH-12  
Max. = 0.003 (kine)  
Min. = -0.003 (kine)

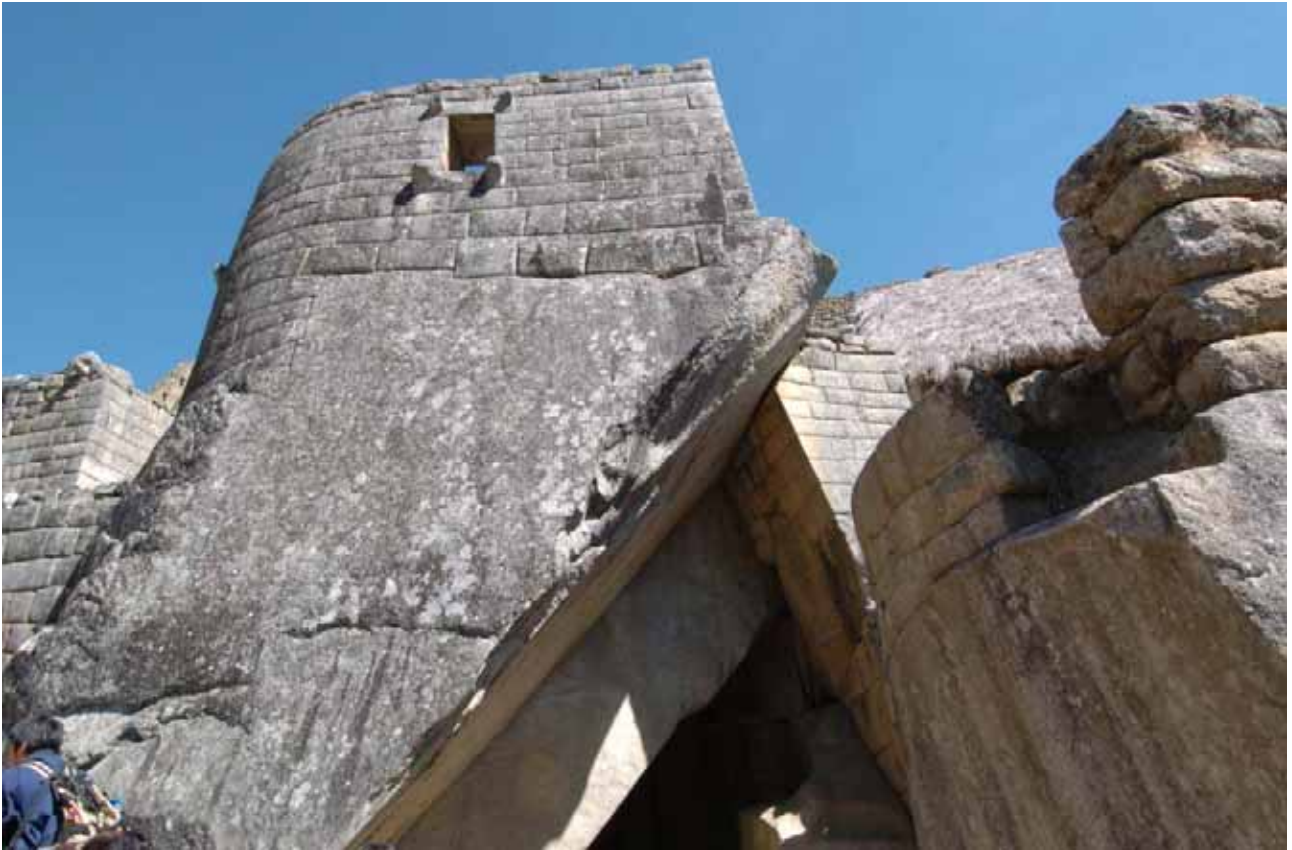
This structure consists of natural rock foundation, where the naturally located rocks are cut to shape with further addition wall over in-situ rock to provide continuous structural shape and stability (right hand side of the photograph). On top of the wall, a circular wall has been constructed which gives this complex the designation as temple of the sun. Three components of microtremors in the upper part and in the bottom part of the structure were measured simultaneously, of which the time domain plots are given below. The first three channels correspond to the upper part of the structure while the last three channels are three components over ground at lower level.

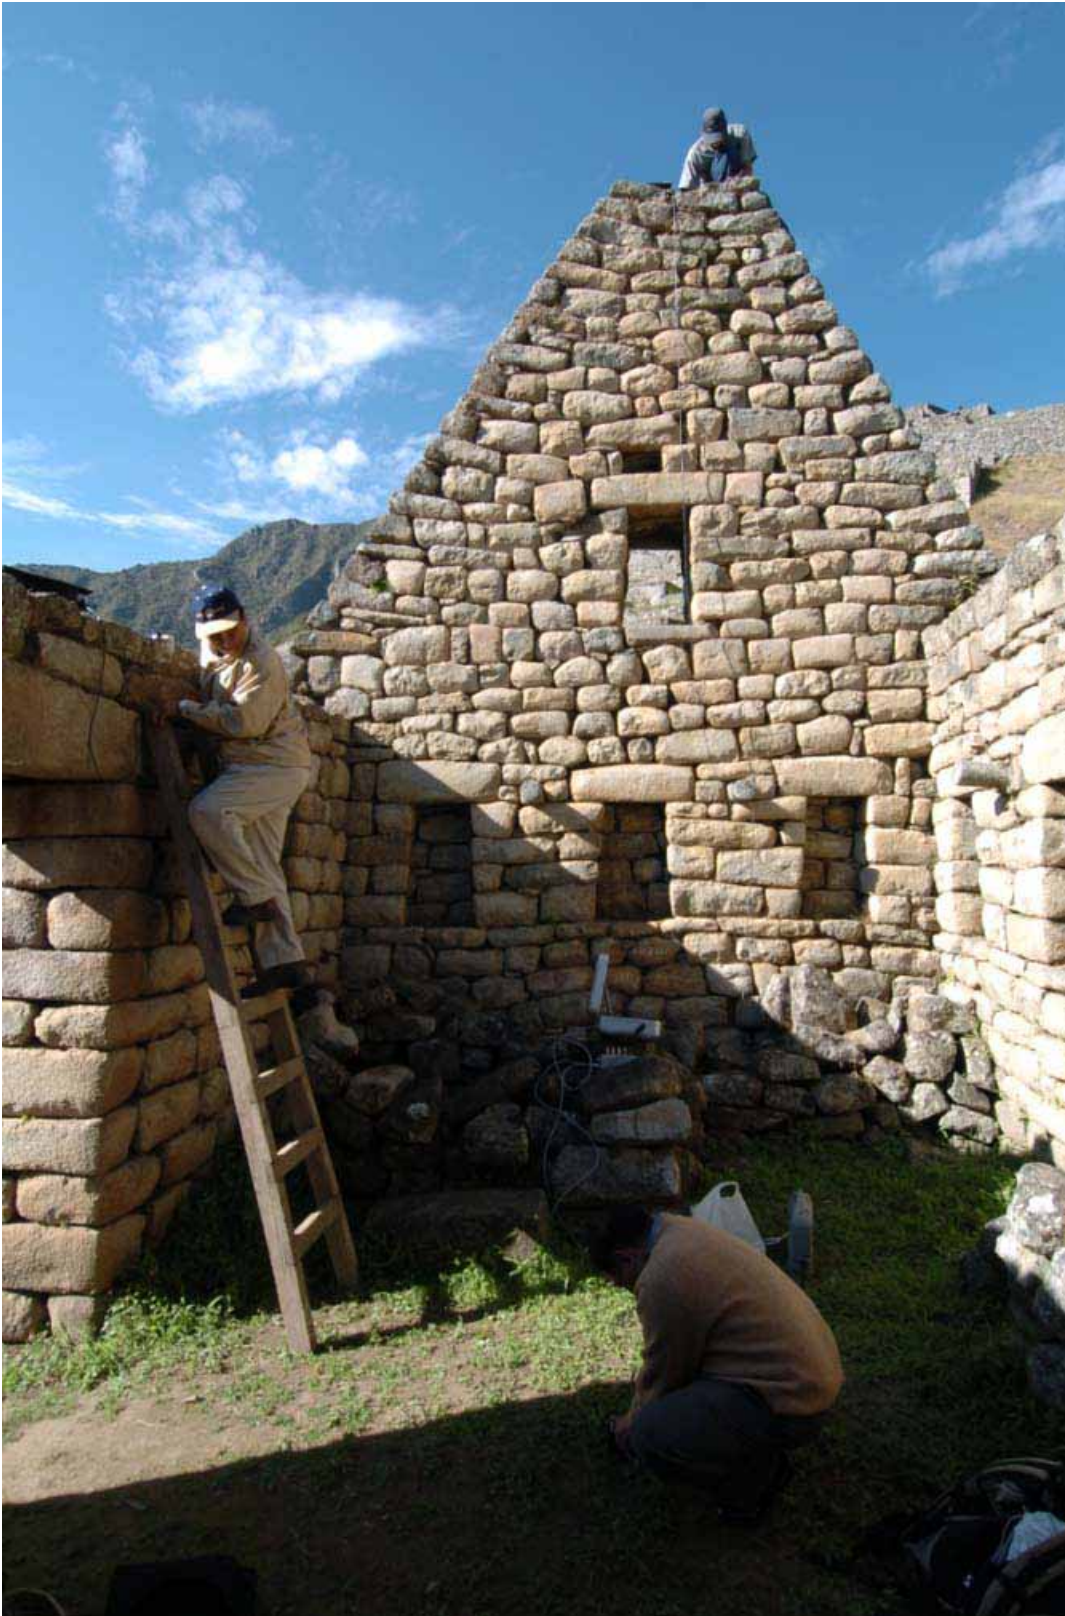
In this case horizontal vibrations were measured. The points of measurement were: the ground, the top of the gable wall, and the top of the normal walls. Measurements were done for the NS direction and EW directions separately. The time domain plots are shown below.
