Earthquake risk to Inca's historical constructions in Machupicchu

C. Cuadra *, M.B. Karkee, K. Tokeshi

Abstract

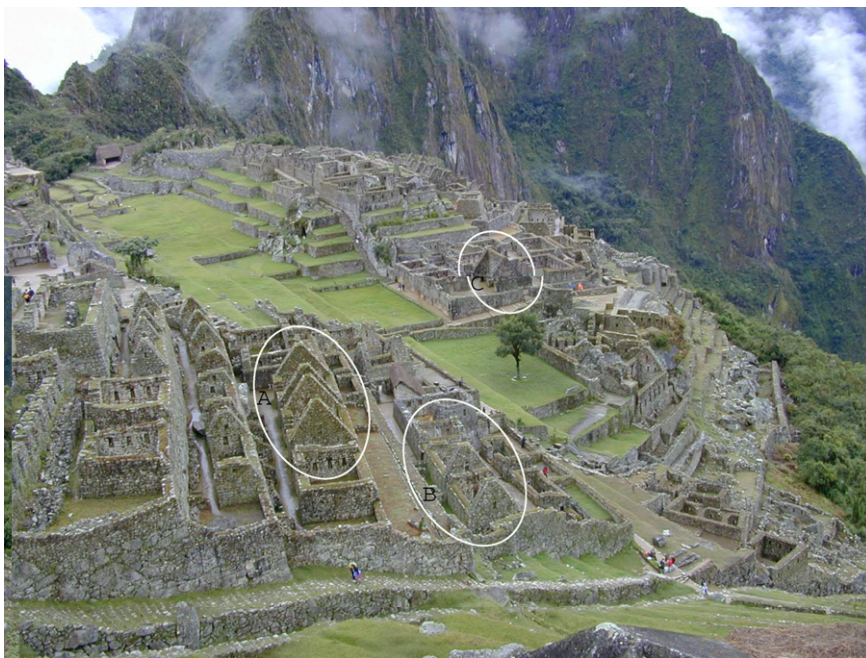
Fig. 7. Typical constructions in Machupicchu citadel.

One of the typical structural components Incas used in their construction was what they called “cancha” that grouped single quadrilateral rooms to form a complex for specific purposes. Typical such structural components at the citadel of Machupicchu that may be considered for analysis are encircled in Fig. 7. These structures have rectangular shape in plan. It is assumed that the stone structures support the vertical load appropriately since the granite stone walls have sufficient compression strength. However, for the case of lateral movement during earthquakes, the structural resistance is expected to be mostly determined by the friction over joints or contact surfaces of the dry stone masonry elements.

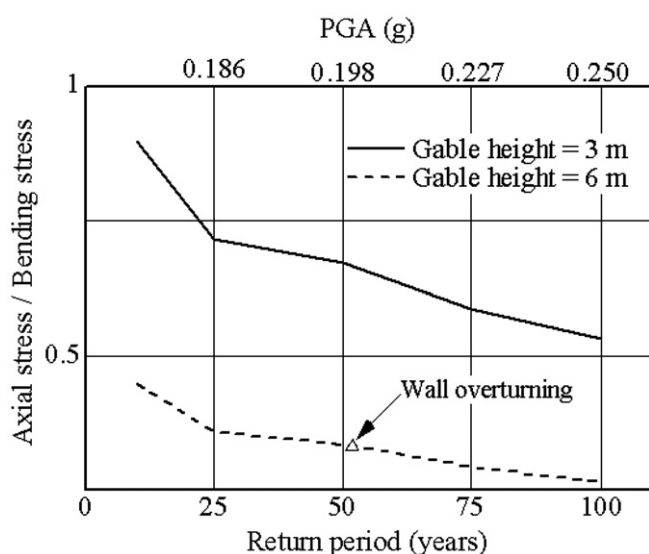
Fig. 10. Stability of stone gable wall under different PGA levels.

The stability of gable wall without restraining is analyzed by considering a lateral inertial force perpendicular to the plane of the wall. As a typical case, the base of the gable wall is taken as 6 m and two cases of height 3 m and 6 m are analyzed. It is assumed that the self-weight produces normal compression stress in the base of the gable wall. Accordingly, the lateral inertial force is considered as acting at the center of mass at one-third the height, producing an overturning moment at the base of the gable wall. If the stress due to the moment becomes larger than the compression stress, it means that tension stresses occur in the wall. However, due to the nature of material used and the way the stone wall is constructed [7], it is clear that

the tension stress is inadmissible if failure by tilting or overturning is to be prevented. To estimate the lateral resistance to seismic action, the mass of the wall and PGA corresponding to the seismic hazard analysis are employed. Fig. 10 shows the ratio between normal stress and bending stress versus different return period for various levels of PGA. In both cases the ratio between compression stress and bending stress does not reach 1.0. This means that for PGA levels corresponding to frequent earthquakes, failure might occur even under the action of relatively small earthquakes. If the gable wall is considered as a rigid body to estimate the overturning failure, by considering the equilibrium of moments due to the horizontal seismic force and due to the vertical weight, it is found that for the gable wall of 3 m height the overturning may occur for a 0.4 g of input acceleration while for the 6 m height this failure occurs for 0.2 g or earthquakes with 50 years of return period.

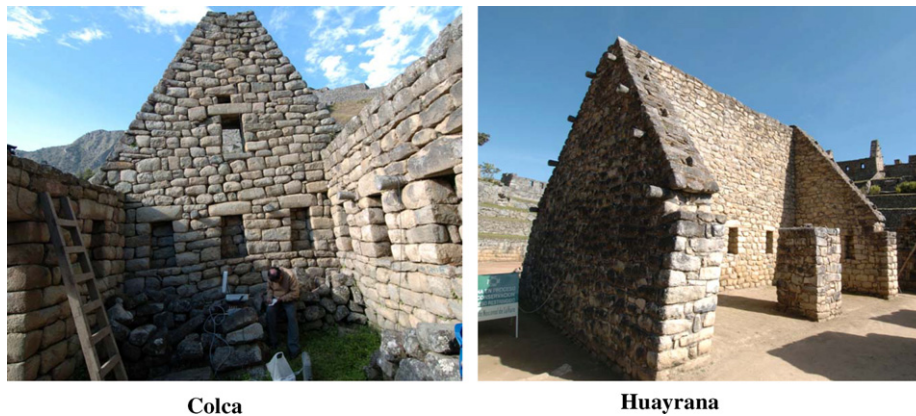
Fig. 11. Selected buildings for analysis of Inca's stone structures.

A series of microtremor measurements were performed at the citadel of Machupicchu, but only the results of microtremor measurements carried out at “Colca” and “Huayrana” are discussed here. These measurements are utilized for estimation of the dynamic characteristics of these two masonry structures shown in Fig. 11. The Colca is 5 m in width, 7 m in length, and 6.5 m in height from the ground level to the top of gable wall. Similarly, the plan of Huayrana is 7.7 m in width, 8.8 m in length, and 6.5 m in height.
