Evaluation of the dynamic characteristics of typical Inca heritage structures in Machupicchu

Abstract

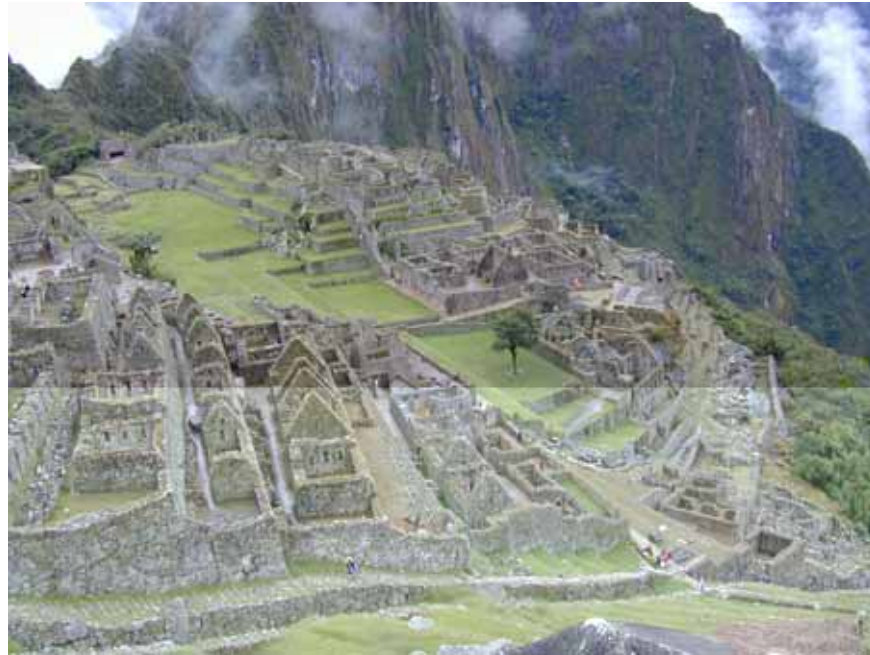
Figure 1: Location of microtremor measurements

All microtremor measurements were performed in the urban sector. In Figure 1 the location of the measurements are indicated by encircled numbers and a brief description of the purpose of each measurements is given as follows.

Plaza (square): Ground vibration measurement. At this site, measurements of the vertical components of the ground vibration were carried out. The sensors were laid in a triangular array system of 30 meter sides. The array measurement is planned for F-K spectral analysis to obtain the characteristic Rayleigh wave dispersion curve, from which the shear wave velocity profile of the ground is estimated by inverse analysis.

Terraces of Intihuatana: Vibration of terraces structures. In this case, horizontal

components of the vibration of the terraces were measured. North-South (NS) direction and East-West (EW) direction were measured separately. Sensors were located at top, intermediate and lowest part of the terraces.

Temple of Three Windows: Structure vibration. Horizontal components of microtremor were measured on the structure and over free field ground at this important part of the Machupicchu citadel. Two horizontal components in NS direction and EW direction were measured separately. Two sensors were located on the ground near the building, one in the external part and another one in the interior of the building. Also, one sensor was located on the central window and another one on the top of the building above the central window.

Principal Temple: Structure vibration. This structure shows evidence of ground settlement on its east wall. In this case the two horizontal components and the vertical component were measured at top of the wall and at ground level.

Temple of the Sun: Structure vibration. This structure consists of natural rock foundation, where the naturally located rocks are cut to shape with further addition wall over in-situ rock to provide continuous structural shape and stability. On top of the wall, a circular wall has been constructed which gives this complex the designation as temple of the sun. Three components of microtremors in the upper part and in the bottom part of the structure were measured simultaneously.

Building No 7 of Group 2: Gable wall and structure vibration. In this case horizontal vibrations were measured. The points of measurement were: the ground, the top of the gable wall, and the top of the normal walls. Measurements were done for the NS direction and EW directions separately.

Building No 2 of the Group of the Mortars: Gable wall and structure vibration. Horizontal vibrations of the structure and ground were measured in this site. The points of measurement were the top of the central wall, the bottom part of the gable wall, the central window of the central wall and the ground. Measurements were carried out for NS direction and EW direction separately. The measurement at this structure is of special interest since its mode of vibration can be compared with the mode of vibration of the previous structures to analyze the restraining effect of the central wall on the behavior of the gable wall.

Terraces at low part of Group 13: Ground vibration. Here the horizontal vibration of the terraces was measured. The direction of measurements was transversal to the valley (right to left in the Figure 1). Measurements were performed here to analyze the behavior of the terraces since they are affected by landslides that may also be triggered by earthquakes. The measurement was performed simultaneously in four consecutive platforms.

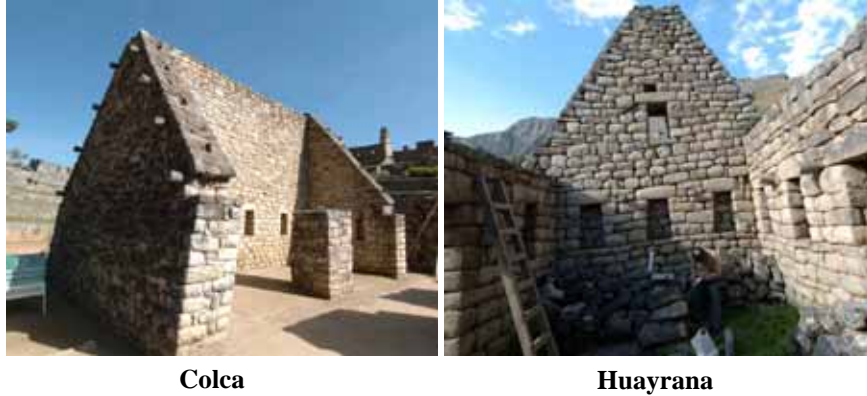
Figure 2: Selected buildings for analysis of Inca's stone structures

Details of these two selected structures are shown in Figure 2. The Colca building has dimensions of 5 m. wide, 7 m large and a height of 6.5 m from ground to top of the gable wall. The Huayrana building has 7.7 m wide, 8.8 large and 6.5 m of height.

The measurements at building No 7 that here is called as “Colca”, and at building No 2 of the group of the mortar that is called as “Huayrana”, are used to estimate the dynamic characteristic of these stone masonry structures.
