SEISMIC DAMAGE TO STONE STRUCTURES IN MACHU PICCHU

C. H. Cuadra¹, K. Tokeshi² and J. G. Rojas³

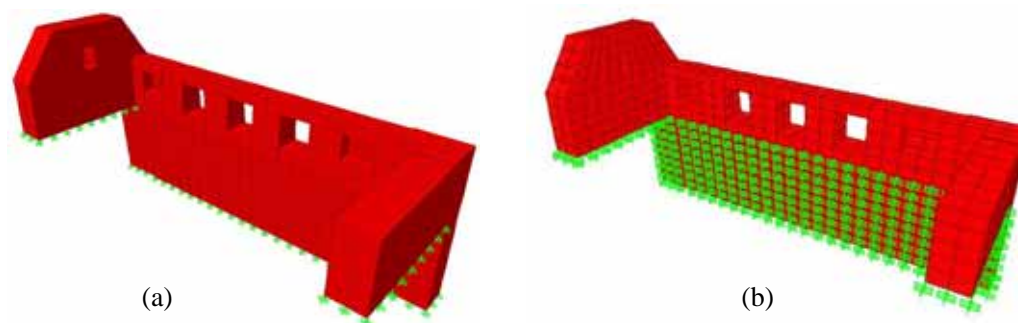
Figure 7. FEM models considered for the Temple of the Three Windows

Since the ground levels of the external side and the inner side of the Temple of the Three Windows are different, two models were considered in the FEM analysis. The first model assumes that the east wall does not have contact with the inner ground, as shown in Figure 7(a). The second model considers that the wall is restrained by the inner ground, as shown in Figure 7(b). The walls were modeled using solid elements, and the elastic linear analysis was applied to compare the results with those obtained by micro vibrations. The appropriate value of the modulus of elasticity was determined by inverse analysis of the values of predominant frequencies estimated from transfer functions of micro vibration measurements. The value of 1.3 kN/mm^2 was obtained for the equivalent elastic modulus, giving good agreements between proper frequencies from FEM and predominant frequencies from micro vibration measurements. Table 1 shows a comparison of the results.

Mode	Micro vibrations	FEM
1 st Mode (Model of Figure 7(a))	6.84	6.93
2 nd Mode (Model of Figure 7(b))	17.10	17.30
