PRELIMINARY OBSERVATIONS ON DAMAGE TO BUILDINGS IN GUJARAT (WESTERN INDIA) EARTHQUAKE OF JANUARY 26, 2001

Madan B. KARKEE

Naoyuki ITAGAKI

ABSTRACT: About three weeks after the Gujarat earthquake, the authors were deployed by the Department of Architecture and Environment, Akita Prefectural University, to undertake a preliminary assessment of the nature of damage to buildings in some of the affected areas of Gujarat. The trip was organized over a very short period and without any detailed planning and without benefit of adequate prior information about field conditions in the earthquake aftermath. Actually, primary objective was to gather the basic necessary factual information about the actual situation in the affected region, based on which other institutions in Japan may be able to organize teams of engineers for more detailed investigation. Further, considering the relief work that was expected to be in full force, the field observations were kept as unintrusive as possible. This report attempts to summarize some preliminary observations based on the field trip by the authors, and mostly consists of photographs of damaged buildings.

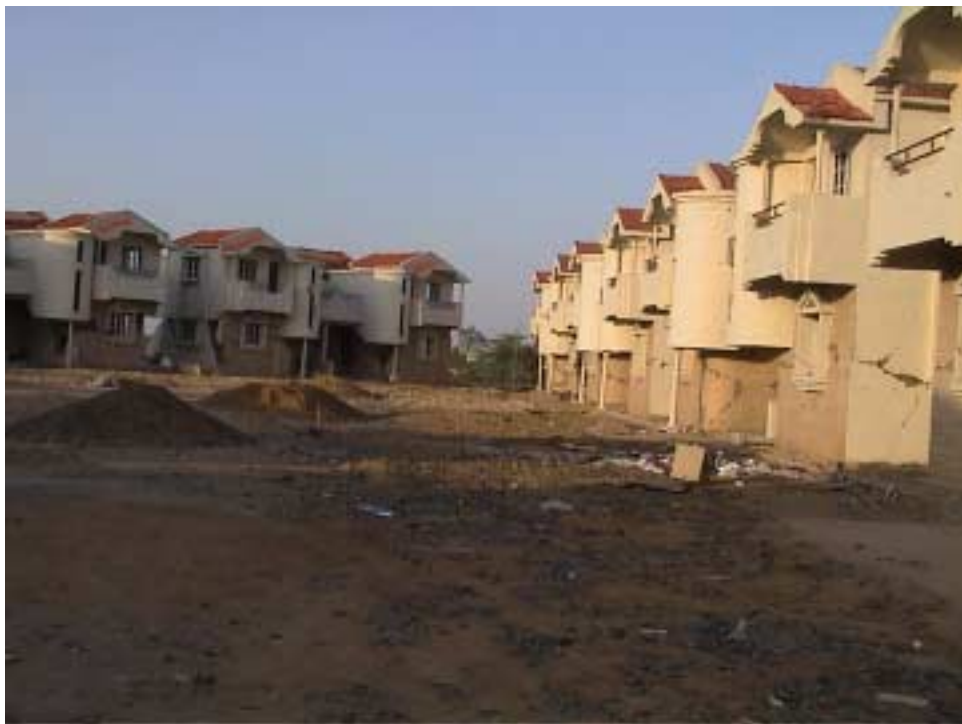
Figure 19. A new housing complex just ready for occupation, consisting of load bearing brick wall structures. The location is between Samakhial and Bhachau, about 80km east of Bhuj.

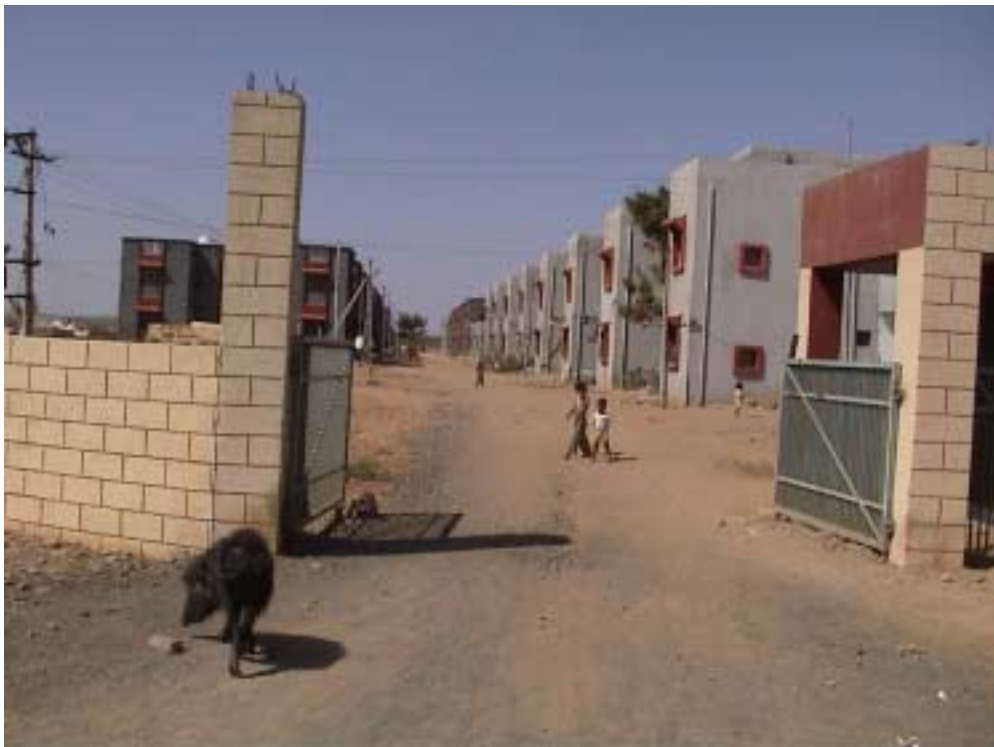
Figure 31. Housing complex with two-storied load bearing brick masonry structures in Bhuj, apparently still occupied after the earthquake.

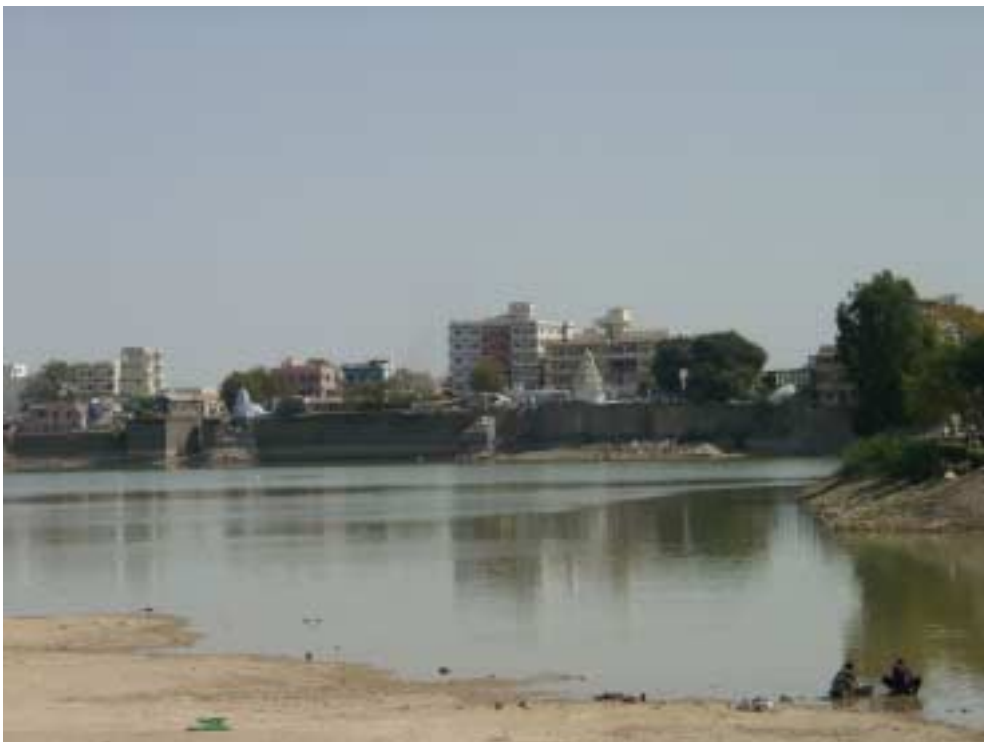
Figure 33. View from the lakeside in Bhuj facing south. Although it was not possible to inspect all the buildings closely, some of the structures in the background seemed to have resisted the earthquake shaking without large scale damage.

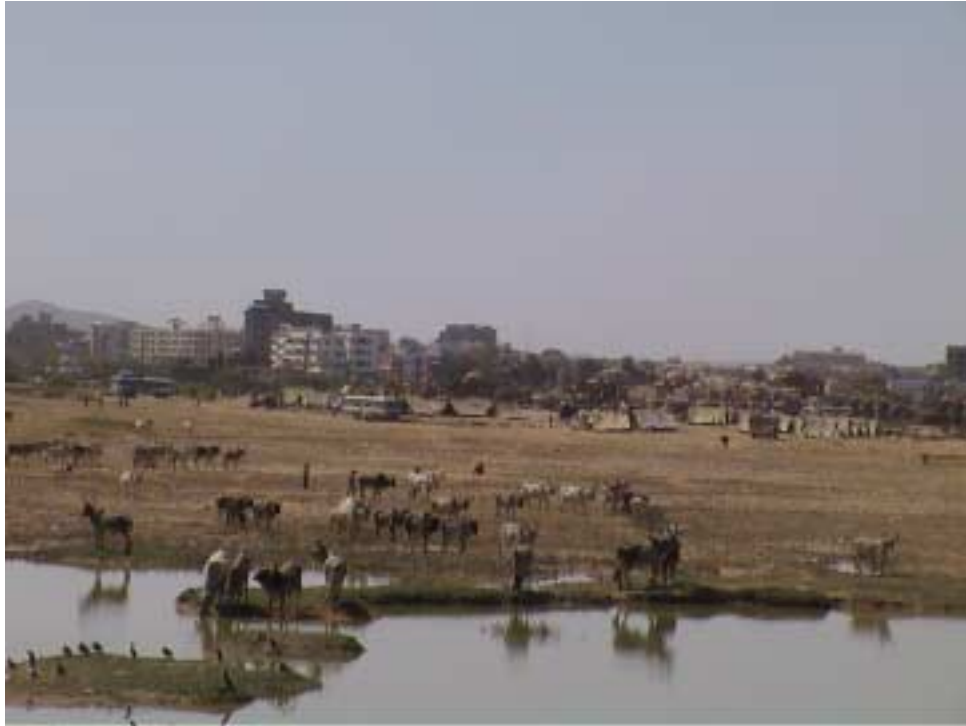
Figure 34. View from the lakeside facing west. Again, some of the building structures in the background seemed to have resisted the shaking without large scale damage. To the right can be seen the historical site of holy burial ground for kings and queens.
